CONTAINER SHIPS

Guidelines for Surveys, Assessment and Repair of Hull Structures

First Edition
ISBN 1 85609 296 8

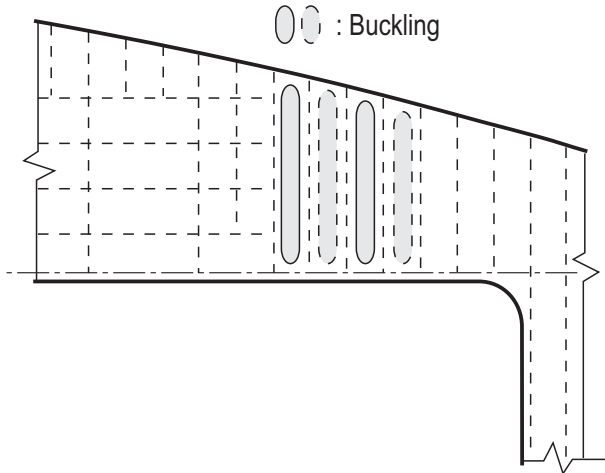
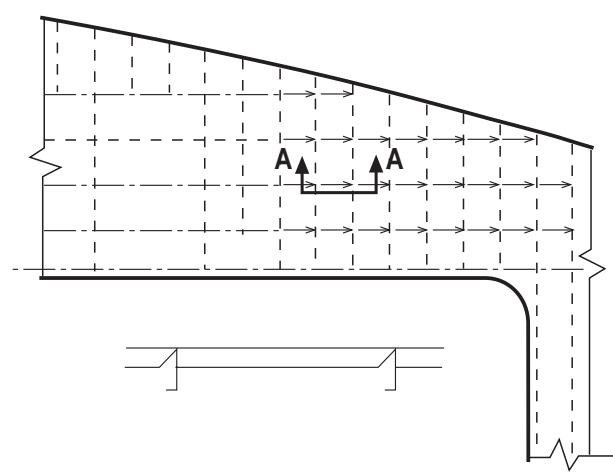
CONTAINER SHIPS		Guidelines for Surveys, Assessment and Repair of Hull Structures	
PART 1	Cargo hold region	EXAMPLE No.	
AREA 1	Upper deck structure including passageways	1	
Detail of damage		Buckling of deck plating of transverse framing system	
<p>Sketch of damage</p>

<p style="text-align: center;">View A-A</p>	
<p>Notes on possible cause of damage</p> <ol style="list-style-type: none"> 1. Excessive compressive stress due to slamming or bow flare effect. 2. Insufficient longitudinal stiffening of deck plating. 		<p>Notes on repairs</p> <ol style="list-style-type: none"> 1. Buckled plating should be cropped and renewed. Longitudinal internal stiffeners should be provided. (Instead of longitudinal stiffeners, renewal by thicker deck plating can be accepted.) 2. Stress concentration may occur at the end of a sniped stiffener resulting in fatigue fractures. For locations where high cyclic stress may occur, appropriate connection such as lug-connection should be considered.

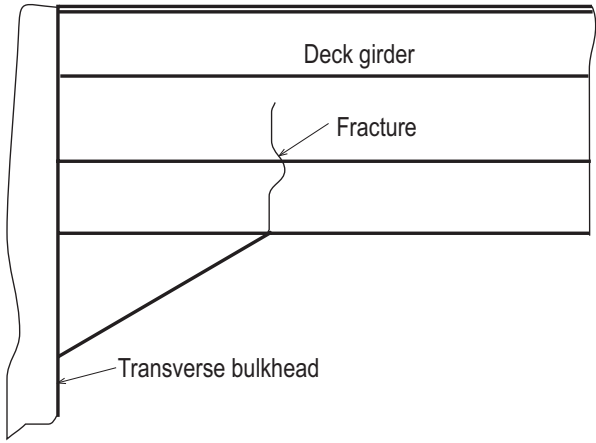
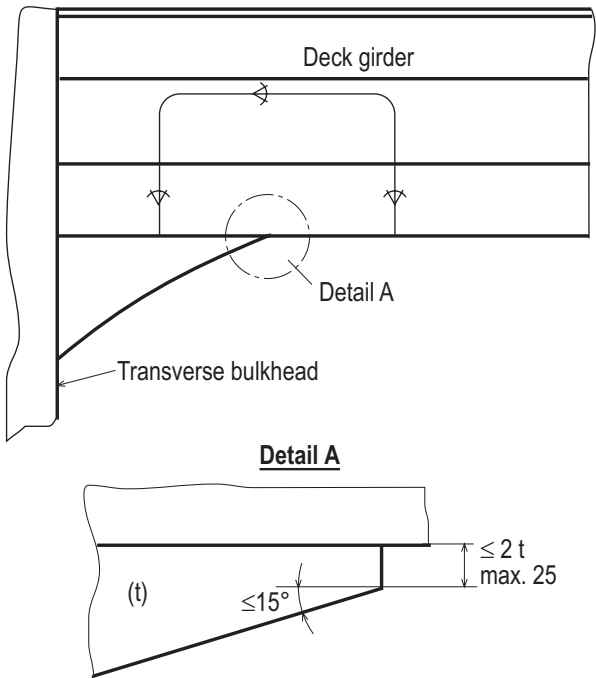
CONTAINER SHIPS		Guidelines for Surveys, Assessment and Repair of Hull Structures	
PART 1	Cargo hold region	EXAMPLE No.	
AREA 1	Upper deck structure including passageways	4	
Detail of damage		Fracture in longitudinal deck girder initiated at bracket toe	
<p>Sketch of damage</p>

<p>The sketch shows a cross-section of a deck girder attached to a transverse bulkhead. A bracket is welded to the bottom flange of the deck girder. A jagged line indicates a fracture at the toe of the bracket.</p>		<p>Sketch of repair</p>

<p>The sketch shows the same deck girder and bulkhead assembly, but with a modified bracket. A dashed circle labeled 'Detail A' indicates the repair area. Below it, 'Detail A' is shown as a trapezoidal bracket with a thickness of (t), a top width of ≤ 2t, a maximum length of 25, and a sloped side at an angle of ≤ 15°.</p>	
<p>Notes on possible cause of damage</p> <ol style="list-style-type: none"> 1. Stress concentration at the toe of deck girder bracket. 		<p>Notes on repairs</p> <ol style="list-style-type: none"> 1. Fractured plating should be cropped and part renewed. 2. Modified soft bracket should be considered.

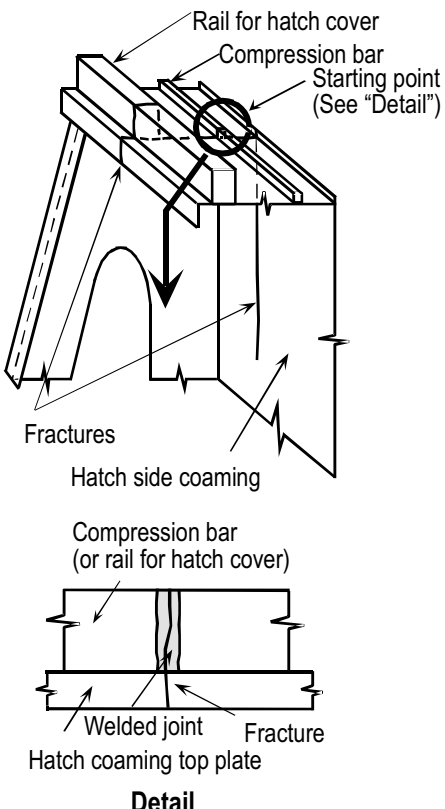
CONTAINER SHIPS		Guidelines for Surveys, Assessment and Repair of Hull Structures	
PART 1	Cargo hold region	EXAMPLE No.	
AREA 1	Upper deck structure including passageways	9	
Detail of damage		Fractures in hatch coaming top plate initiated from butt weld of compression bar	
<p>Sketch of damage</p>

<p>Rail for hatch cover Compression bar Starting point (See "Detail") Fractures Hatch side coaming Compression bar (or rail for hatch cover) Welded joint Fracture Hatch coaming top plate Detail</p>		<p>Sketch of repair</p>

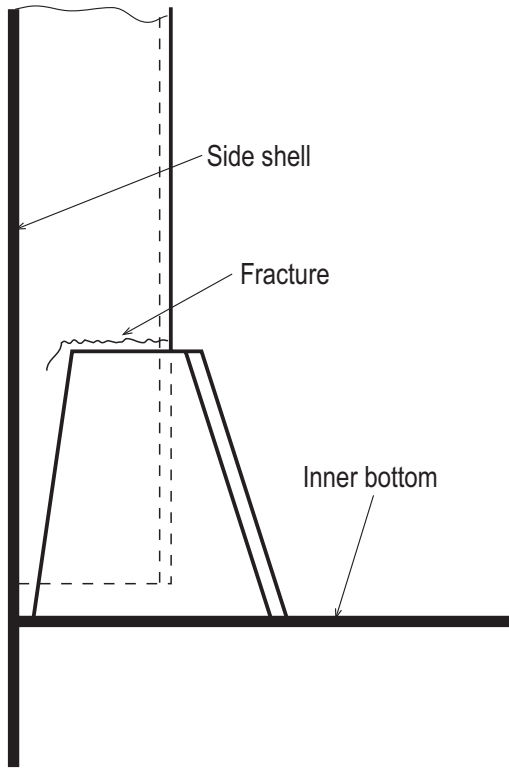
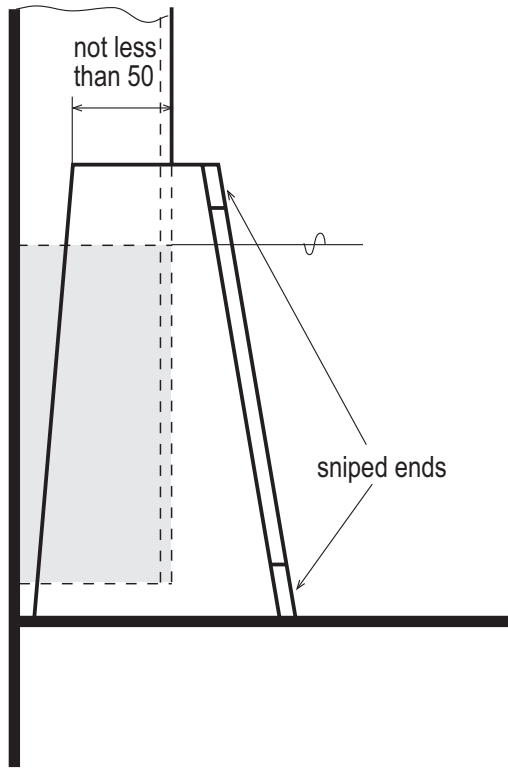
<p>Notes on possible cause of damage</p> <p>1. This type of damage is caused due to stress concentration.</p>		<p>Notes on repairs</p> <ol style="list-style-type: none"> 1. For small fractures, e.g. hairline fractures, the fracture can be veed-out, welded up, ground, examined by NDT for fractures, and rewelded. 2. For larger / significant fractures consideration is to be given to cropping and partly renewing / renewing the frame brackets. If renewing the brackets, end of frames can be sniped to soften them. 3. If considered necessary soft toes may be incorporated at the boundaries of the bracket to the inner bottom plating.

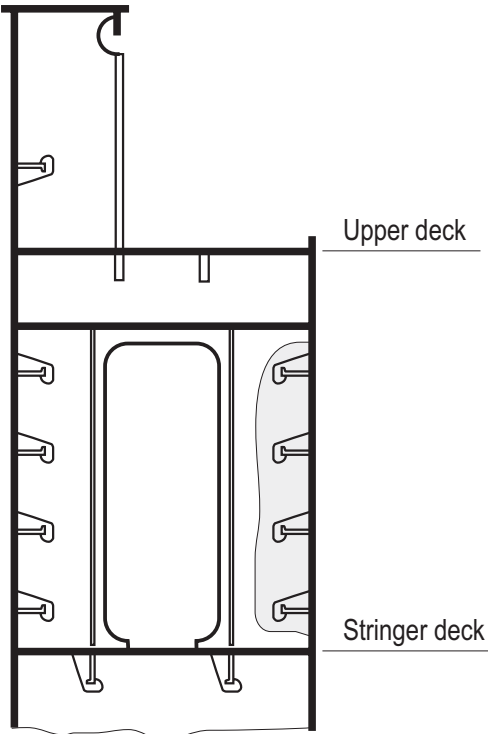
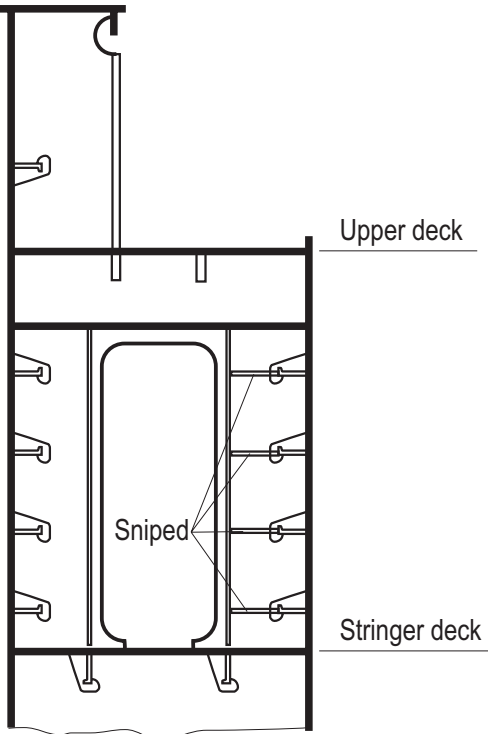
<p>Notes on possible cause of damage</p> <ol style="list-style-type: none"> 1. Deformation of web of transverse web frame and / or distortion of side longitudinals due to insufficient buckling strength. 2. Insufficient strengthening of side structure in way of tug and / or fender area or misplacing of strengthened area, respectively. 		<p>Notes on repairs</p> <ol style="list-style-type: none"> 1. Straightening or renewal (if necessary) of buckled web plate and distorted side longitudinals. 2. Fitting of additional horizontal stiffeners on web plate in way of side longitudinals. 3. Strengthening of tug or fender area or shifting of affected area to right position should be considered.

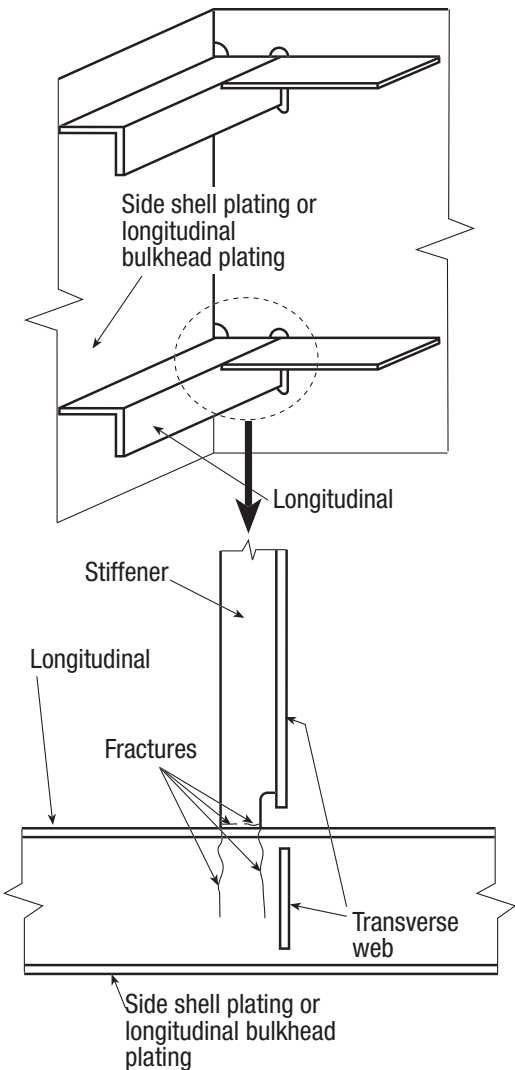
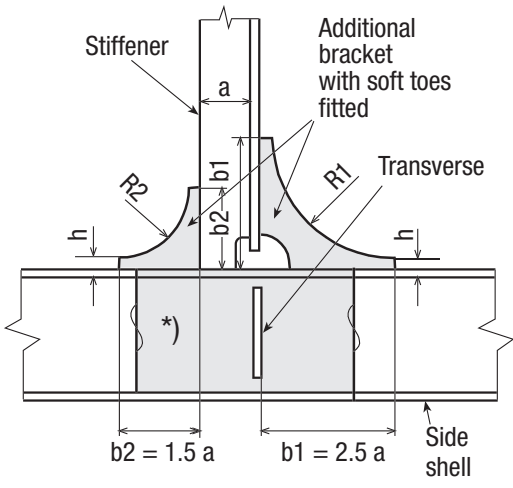
<p>Side shell plating or longitudinal bulkhead plating</p> <p>Longitudinal</p> <p>Stiffener</p> <p>Longitudinal</p> <p>Fractures</p> <p>Transverse web</p> <p>Side shell plating or longitudinal bulkhead plating</p>		<p>Sketch of repair</p>

<p>Stiffener</p> <p>Additional bracket with soft toes fitted</p> <p>Transverse</p> <p>Side shell</p> <p>$b2 = 1.5 a$</p> <p>$b1 = 2.5 a$</p> <p>*) Where required, the longitudinal to be cropped and part renewed</p> <ol style="list-style-type: none"> 1. For a slope at toes max. 1:3, $R1 = (b1 - h) \times 1.6$ and $R2 = (b2 - h) \times 1.6$ 2. Soft toe bracket to be welded first to longitudinal 3. Scallop in bracket to be as small as possible recommended max. 35mm 4. If toes of brackets are ground smooth, full penetration welds in way to be provided 5. Maximum length to thickness ratio = 50:1 for unstiffened bracket edge 6. Toe height, h, to be as small as possible (10-15 mm)

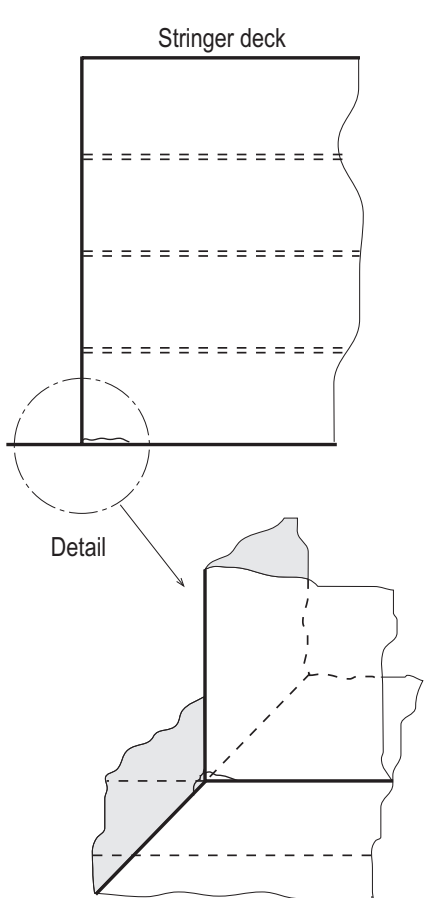
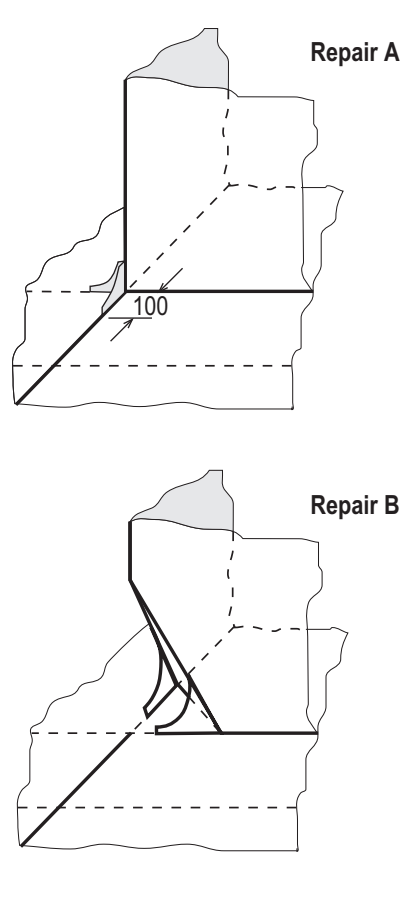
<p>Notes on possible cause of damage</p> <ol style="list-style-type: none"> 1. Damage can be caused by stress concentration leading to fatigue in this region. 		<p>Notes on repairs</p> <ol style="list-style-type: none"> 1. Fracture in tank top plating to be cropped and renewed by insert. 2. Repair A: Small brackets should be provided at the termination in longitudinal and / or transverse direction (proposed length about 100 mm) 3. Repair B: Modification of the design with soft nose transition should be considered.

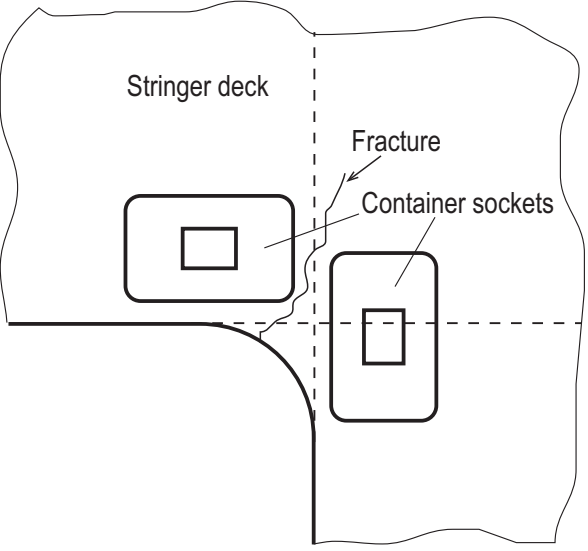
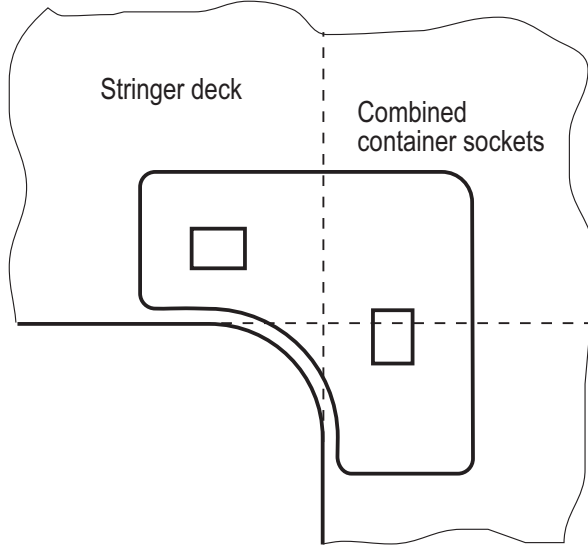
<p>Notes on possible cause of damage</p> <ol style="list-style-type: none"> 1. Stress concentration in the radiused corner in combination with stress concentration due to the arrangement of two separate container sockets. 2. Missing or insufficient support by internal structure in way of the container sockets. 		<p>Notes on repairs</p> <ol style="list-style-type: none"> 1. Fractured plating of stringer deck to be cropped and renewed by insert. 2. Use of a combined container socket instead of two separate sockets. 3. Additional internal stiffening structure should be considered, if necessary

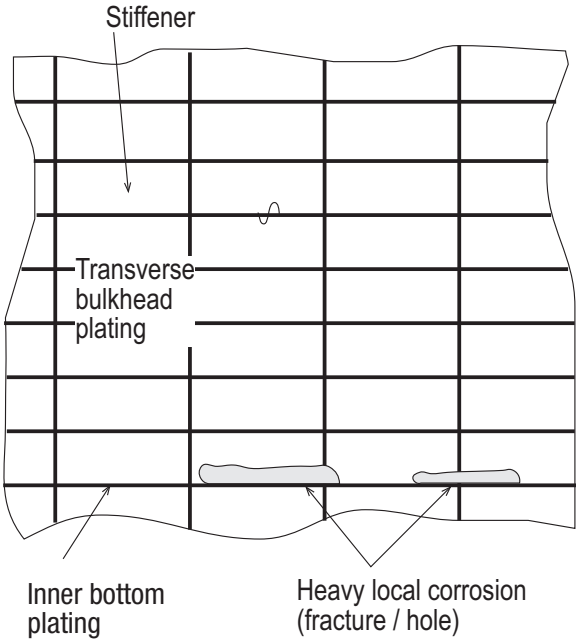
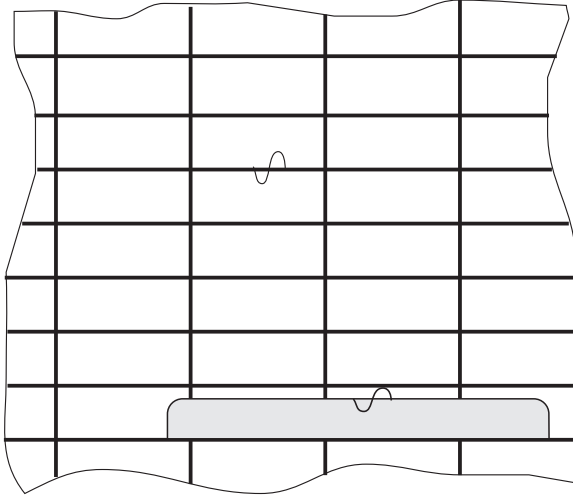
<p>Stiffener</p> <p>Transverse bulkhead plating</p> <p>Inner bottom plating</p> <p>Heavy local corrosion (fracture / hole)</p>		<p>Sketch of repair</p>

<p>Notes on possible cause of damage</p> <ol style="list-style-type: none"> 1. Heavy corrosion including grooving along inner bottom. 		<p>Notes on repairs</p> <ol style="list-style-type: none"> 1. The extent of the renewal should be determined carefully. If the renewal plate (original thickness) is welded to thin plate (corroded plate), it may cause stress concentration and cause fracture. 2. Protective coating should be applied.

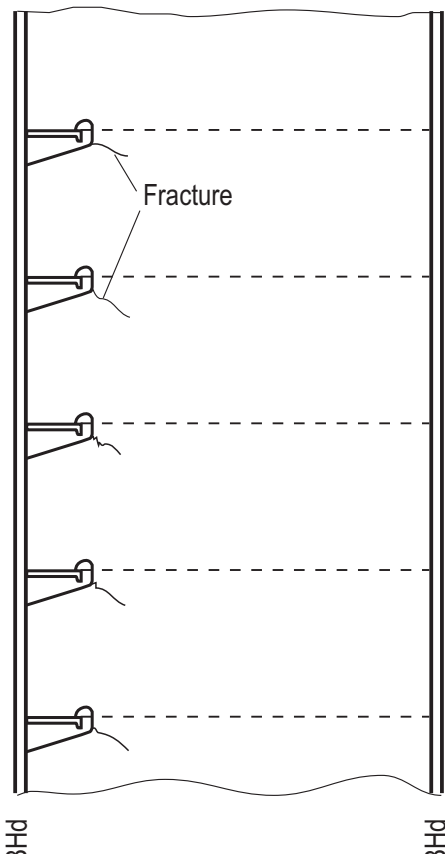
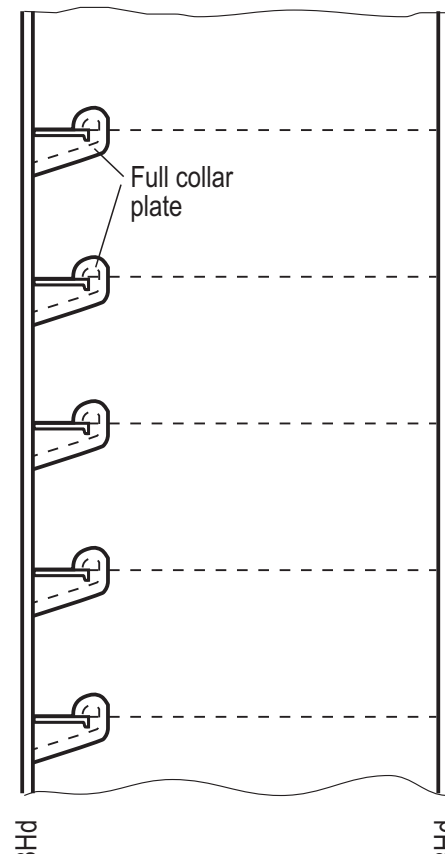
<p>Notes on possible cause of damage</p> <p>1. Damage caused by stress concentration leading to fatigue fractures.</p>		<p>Notes on repairs</p> <p>1. The fractured plating is to be cropped and part renewed as necessary.</p> <p>2. Collar plates to cut-outs are to be installed.</p>

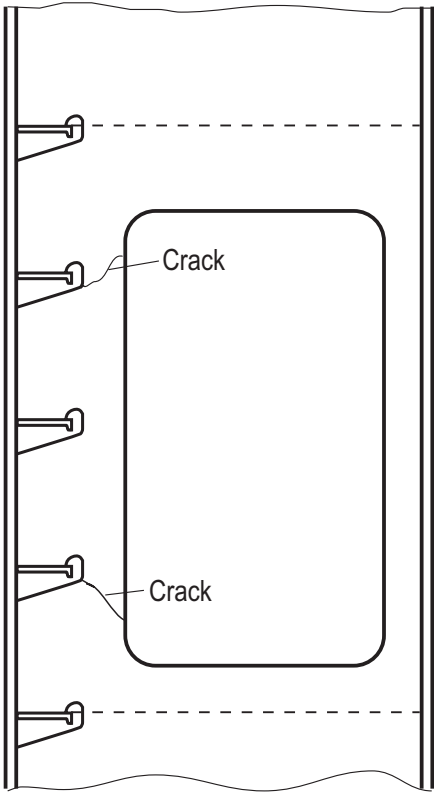
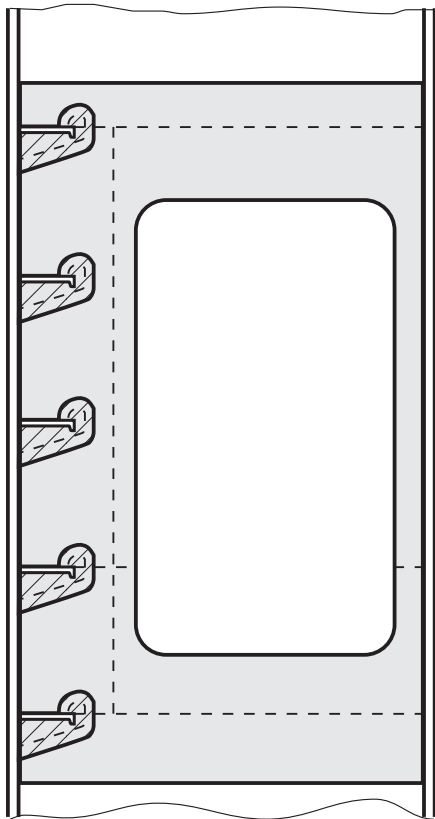
<p>Notes on possible cause of damage</p> <p>1. Damages caused by stress concentration leading to fatigue fractures.</p>		<p>Notes on repairs</p> <p>1. Insertion of plating of increased thickness (chamfer 1:3 to 1:5).</p> <p>2. Collar plates to cut-outs for vertical stiffeners are to be installed.</p> <p>3. Additional stiffener adjacent to access opening to be fitted</p> <p>4. Reduction in size of access hole to be considered.</p>

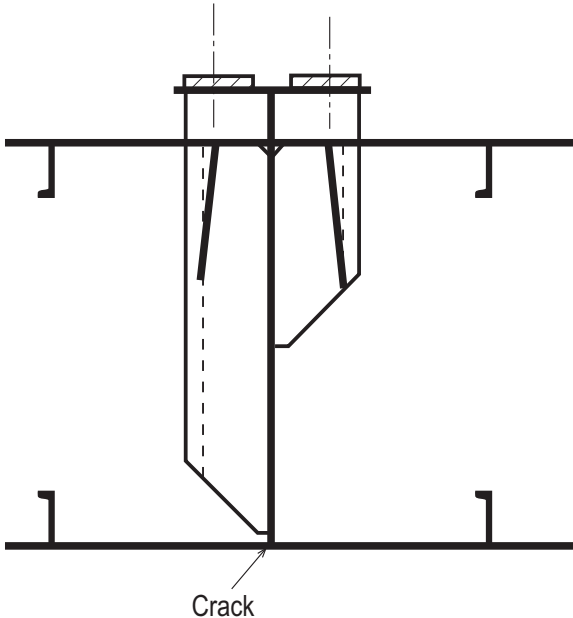
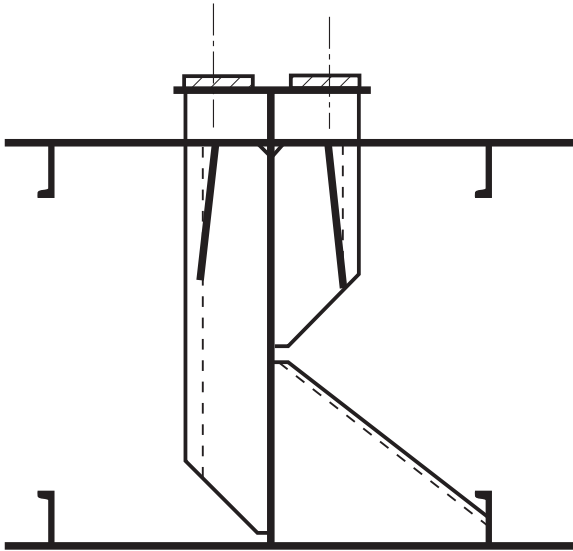
<p>Notes on possible cause of damage</p> <p>1. Damage can be caused by an insufficient strength of the longitudinal girder at the termination of the vertical stiffeners. The effect of a simultaneous occurrence of the tank pressure from one side and an asymmetrical load from the container sockets has not been taken into account.</p>		<p>Notes on repairs</p> <p>1. Fractured part of the longitudinal girder has to be cropped and renewed by an insert.</p> <p>2. The lower part of the girder has to be supported by an additional transverse stiffener on the bottom shell plating.</p>

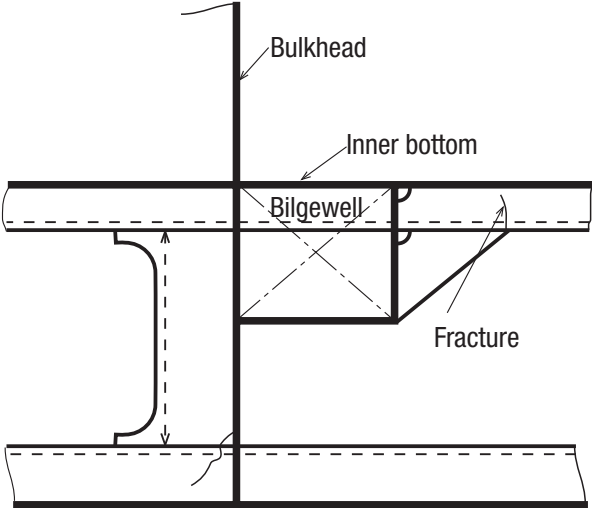
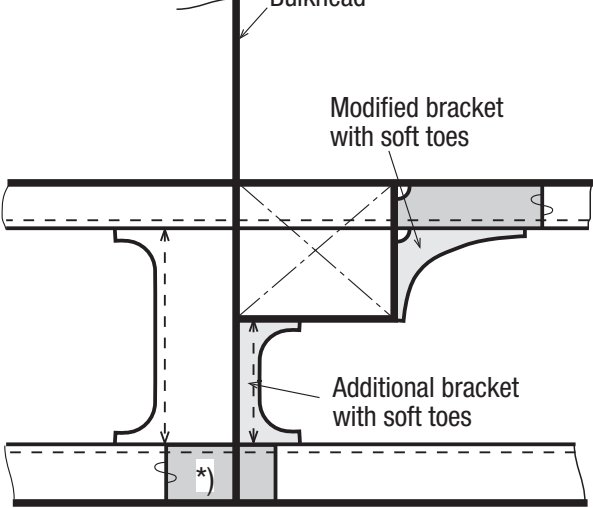
<p>*) : Where required the longitudinals to be cropped and part renewed</p>	
<p>Notes on possible cause of damage</p> <p>1. Damage can be caused by stress concentrations leading to accelerated fatigue in this region.</p>		<p>Notes on repairs</p> <p>1. If fractures are not extensive e.g. hairline fractures then these can be veed-out and welded.</p> <p>2. If the fracture has extended to over one third of the depth of the longitudinal then crop and part renew.</p>

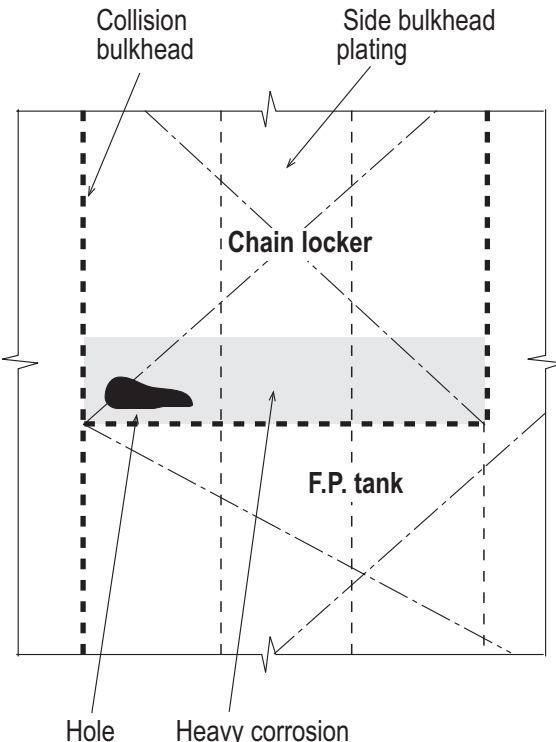
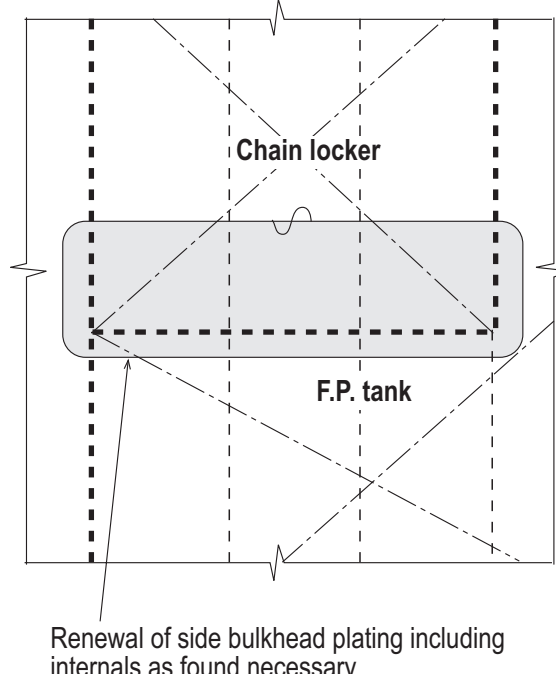
<p>The sketch shows a cross-section of a hull structure. On the left is the 'Collision bulkhead'. To its right is the 'Side bulkhead plating'. Below the side bulkhead is the 'Chain locker', and below that is the 'F.P. tank'. A dark, irregular shape labeled 'Hole' is shown in the side bulkhead plating, with an arrow pointing to it. Another arrow points to a shaded area labeled 'Heavy corrosion' in the same plating. Dashed lines indicate the boundaries of the chain locker and F.P. tank.</p>		<p>Sketch of repair</p>

<p>The sketch shows the same hull structure as the damage sketch. The 'Chain locker' and 'F.P. tank' are labeled. A shaded rectangular area with rounded corners is shown where the side bulkhead plating has been renewed. An arrow points to this area with the text 'Renewal of side bulkhead plating including internals as found necessary'. Dashed lines indicate the boundaries of the chain locker and F.P. tank.</p>

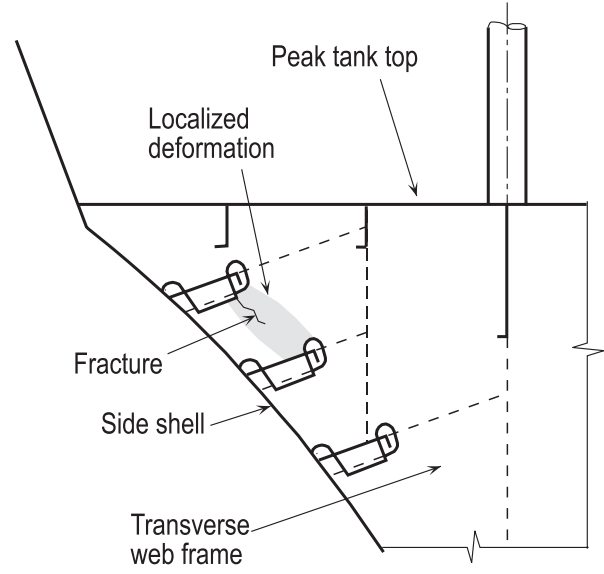
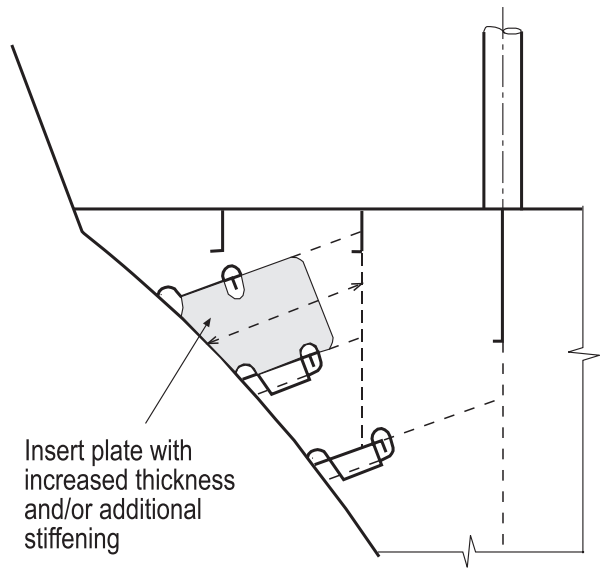
<p>Notes on possible cause of damage</p> <ol style="list-style-type: none"> 1. Localized material wastage in way of coating failure at cut-outs and sharp edges due to working of the structure. 2. Dynamic seaway loading in way of bow flare. 		<p>Notes on repairs</p> <ol style="list-style-type: none"> 1. Sufficient panel strength to be provided to absorb the dynamic loads enhanced by bow flare shape.

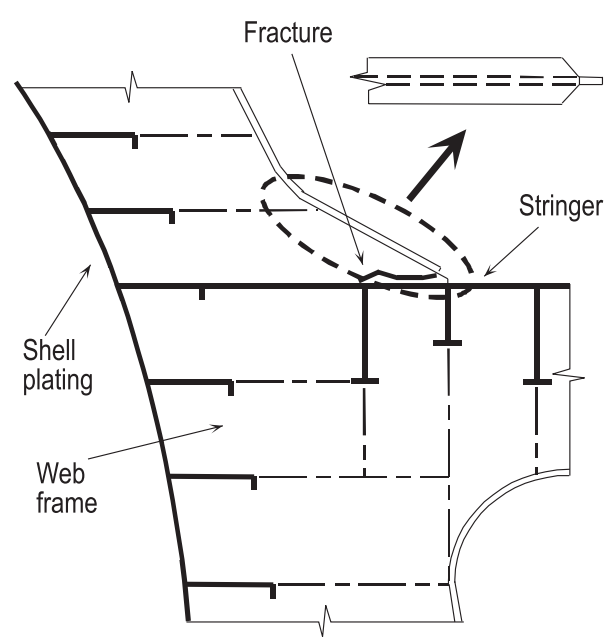
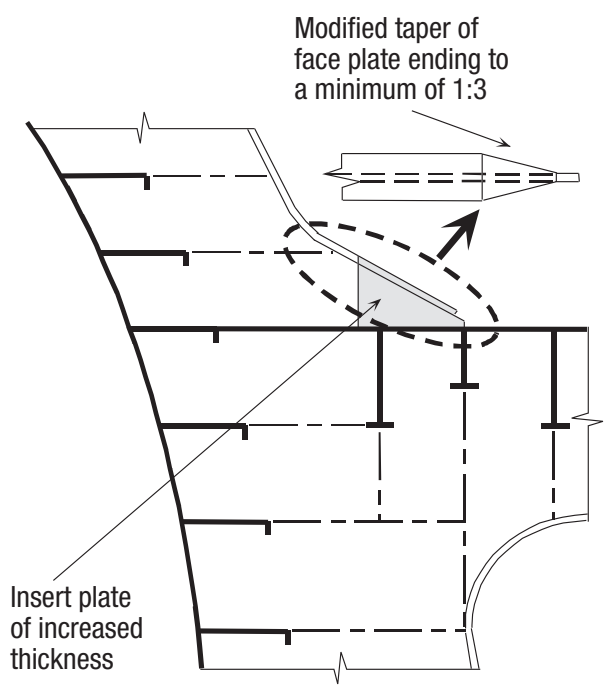
<p>Notes on possible cause of damage</p> <ol style="list-style-type: none"> 1. Inadequate bracket forming the web frame connection to the stringer. 2. Localized material wastage in way of coating failure at bracket due to flexing of the structure. 3. Dynamic seaway loading in way of bow flare. 		<p>Notes on repairs</p> <ol style="list-style-type: none"> 1. Adequate soft nose bracket endings with a face plate taper of at least 1 : 3 to be provided.

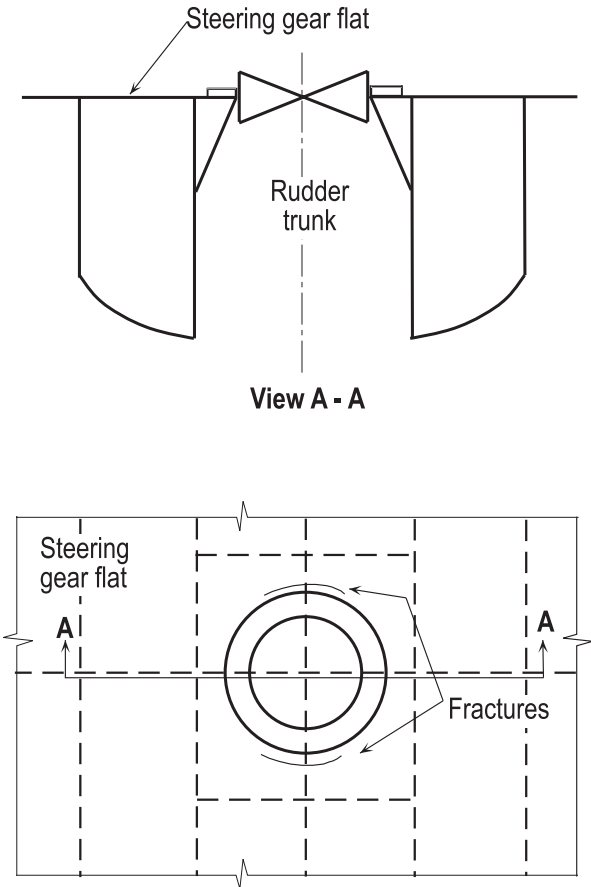
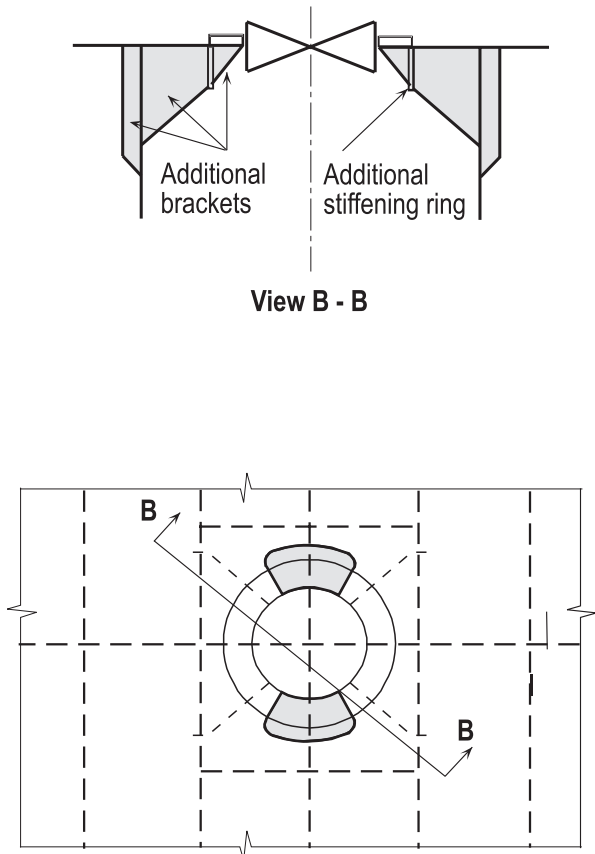
<p>View B - B</p>	
<p>Notes on possible cause of damage</p> <ol style="list-style-type: none"> 1. Inadequate design. 		<p>Notes on repairs</p> <ol style="list-style-type: none"> 1. Fractured plating should be cropped and renewed. 2. Additional brackets and stiffening ring should be fitted for reinforcement.

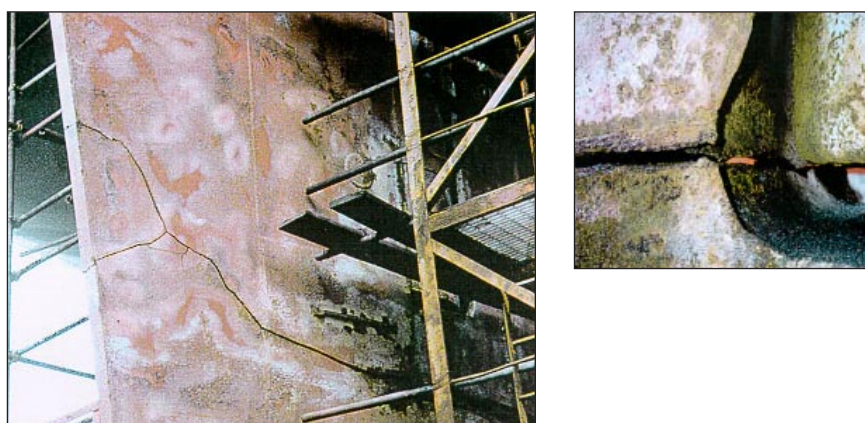
Photograph 1 Fractured rudder

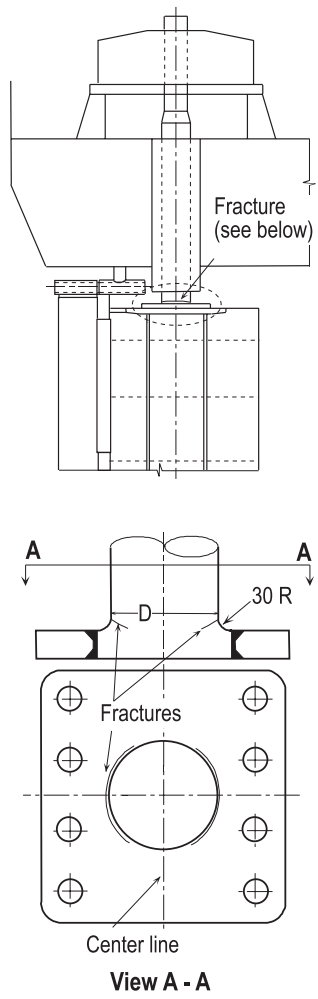
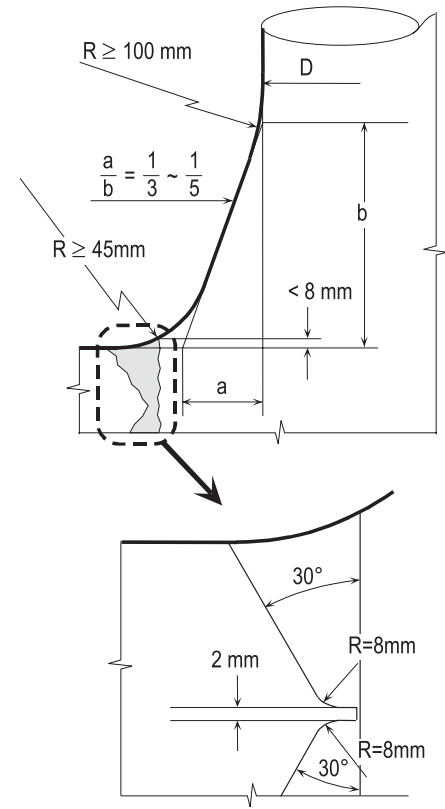
<p>Fracture (see below)</p> <p>View A - A</p>		<p>Sketch of repair</p>

<p>Notes on possible cause of damage</p> <ol style="list-style-type: none"> Inadequate design for stress concentration in rudder stock. 		<p>Notes on repairs</p> <ol style="list-style-type: none"> Modification of detail design of rudder stock to reduce the stress concentration.

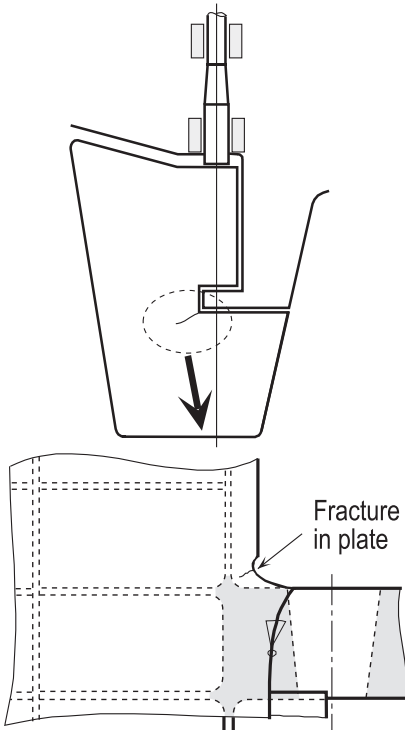
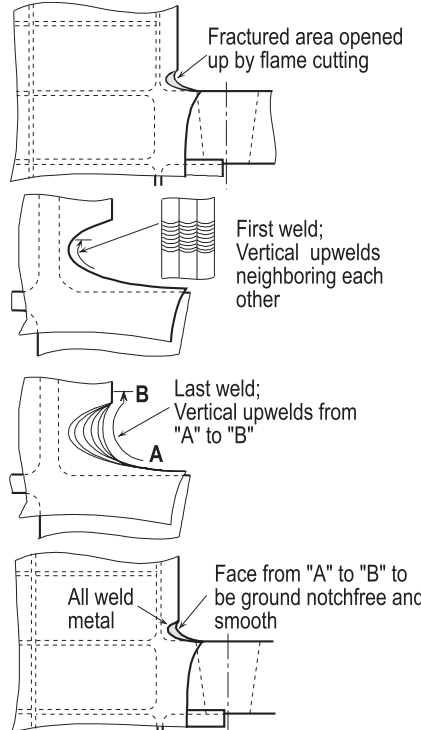
<p>Notes on possible cause of damage</p> <ol style="list-style-type: none"> 1. Stress concentration due to inadequate local design and/or fabrication notches in way of the butt weld between cast piece and plating. 		<p>Notes on repairs</p> <ol style="list-style-type: none"> 1. Grooving-out and welding of the fracture is not always adequate (metallurgical notch in way of a high stressed area). 2. In the proposed repair procedure the metallurgical notches are shifted into a zone exposed to lower stresses. 3. After welding a modification of the radius according to the proposal in Example 5 is to be carried out. 4. In the case of very small crack it can be ground off by increasing the radius.

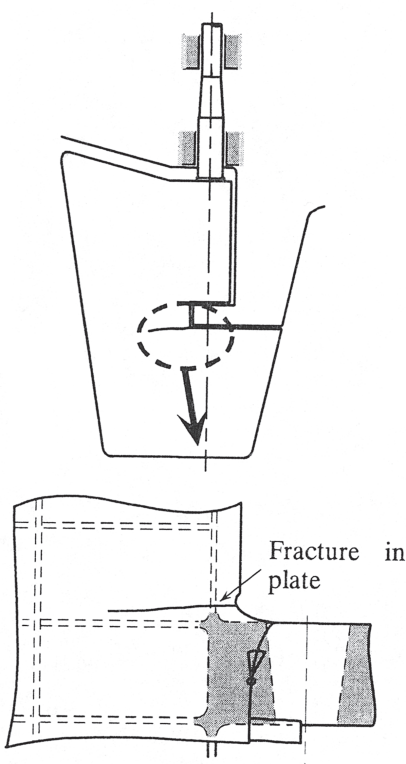
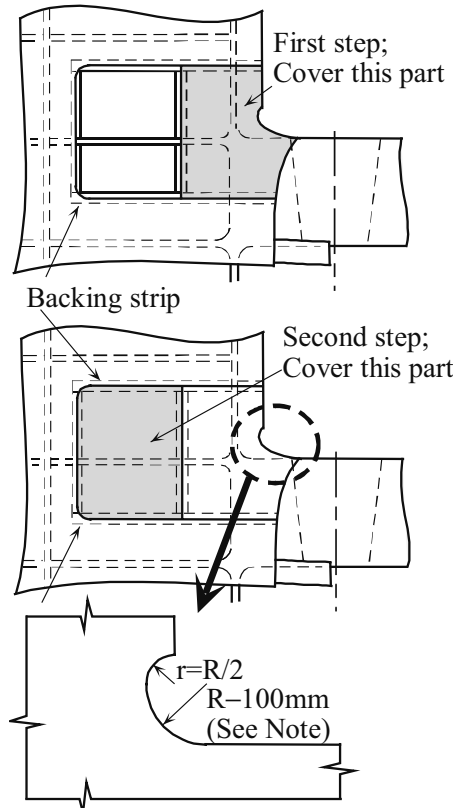
<p>Note: R should be considered according to local detail</p>	
<p>Notes on possible cause of damage</p> <ol style="list-style-type: none"> 1. Stress concentration due to inadequate local design and/or fabrication notches in way of the butt weld between cast piece and plating. 		<p>Notes on repairs</p> <ol style="list-style-type: none"> 1. Fractured plating is to be cut-out. 2. Internal structures are to be checked. 3. Cut-out is to be closed by an insert plating according to the sketch (welding only from one side is demonstrated). 4. Modification of the radius. 5. In the case of a new cast piece, connection with the plating is to be shifted outside the high stress area.

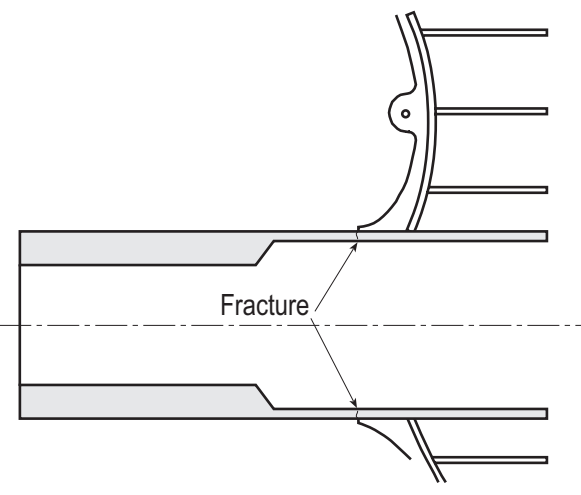
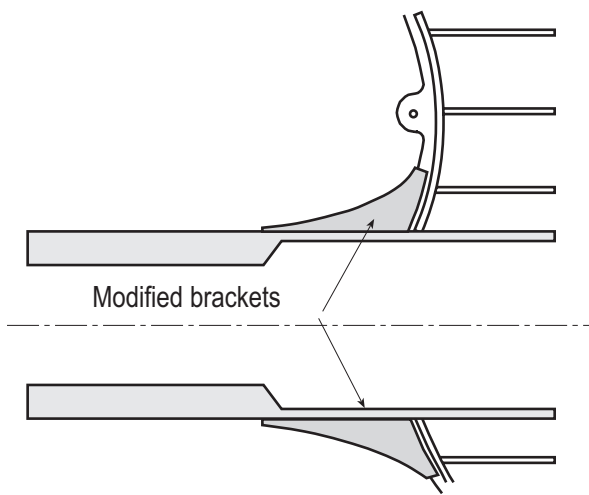
<p>The sketch shows a cross-section of the stern tube and its connection to the stern frame. A clear fracture is visible at the junction where the tube meets the frame. The label 'Fracture' has arrows pointing to the broken area on both the upper and lower parts of the tube.</p>		<p>Sketch of repair</p>

<p>The sketch shows the same cross-section as the damage sketch, but with a repair. The fractured area has been removed and replaced with a section of tube. The brackets at the connection have been replaced with 'Modified brackets' that have a smooth, curved transition between the tube and the frame. The label 'Modified brackets' has arrows pointing to these new brackets.</p>

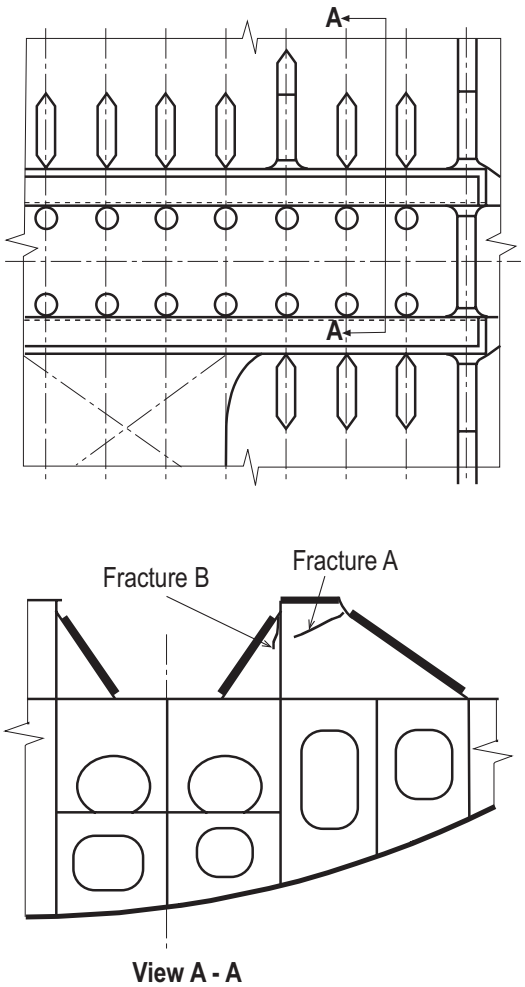
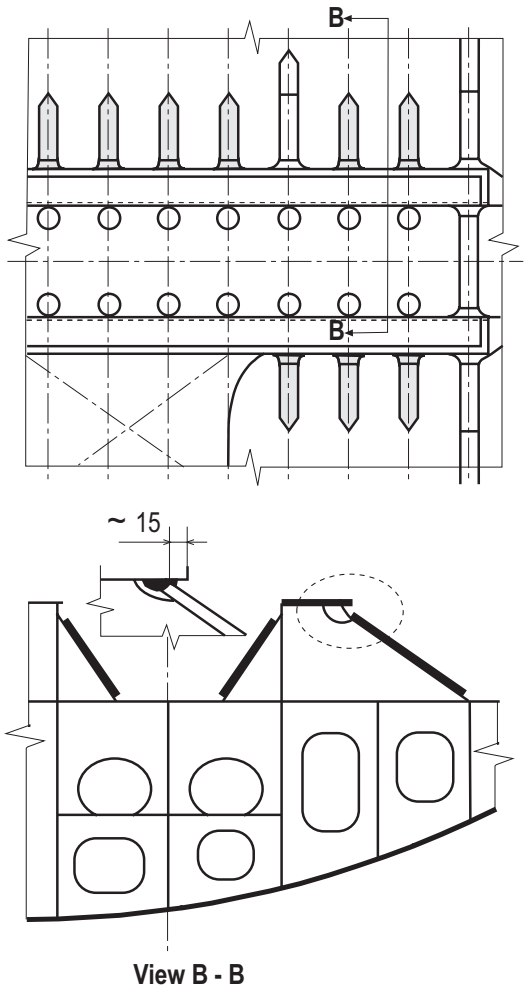
<p>View B - B</p>	
<p>Notes on possible cause of damage</p> <ol style="list-style-type: none"> 1. Vibration of main engine. 2. Insufficient strength of brackets at main engine foundation. 3. Insufficient pre-load in bolts. 		<p>Notes on repairs</p> <ol style="list-style-type: none"> 1. Fractures are to be veed-out and rewelded. 2. New modified brackets at main engine foundation. 3. Or insert pieces and additional flanges to increase section modulus of the brackets.

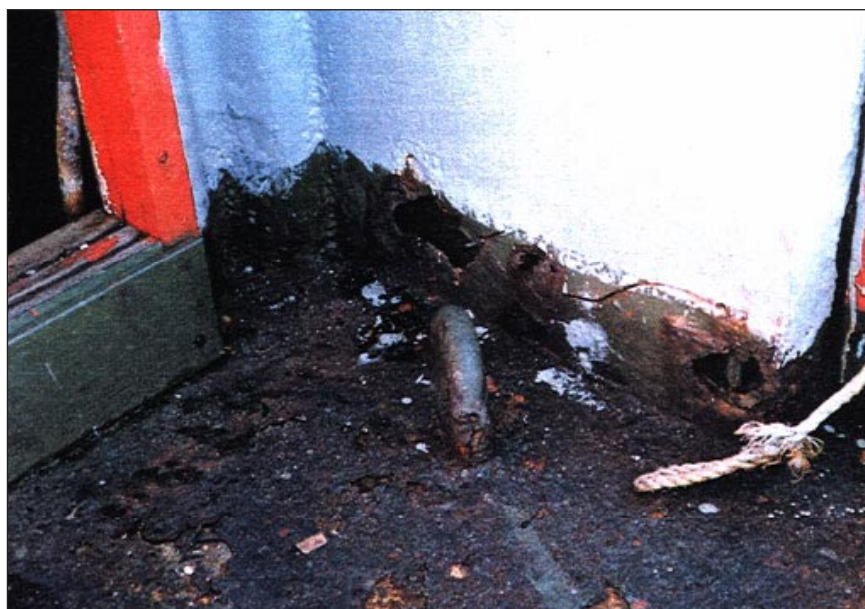
Photograph 1 Corroded accommodation house side structure
