**No.55 GENERAL CARGO SHIPS - Guidelines For
Surveys, Assessment and Repair of Hull
Sturcture**

GENERAL CARGO SHIPS

Guidelines for Surveys,
Assessment and Repair
of Hull Structure

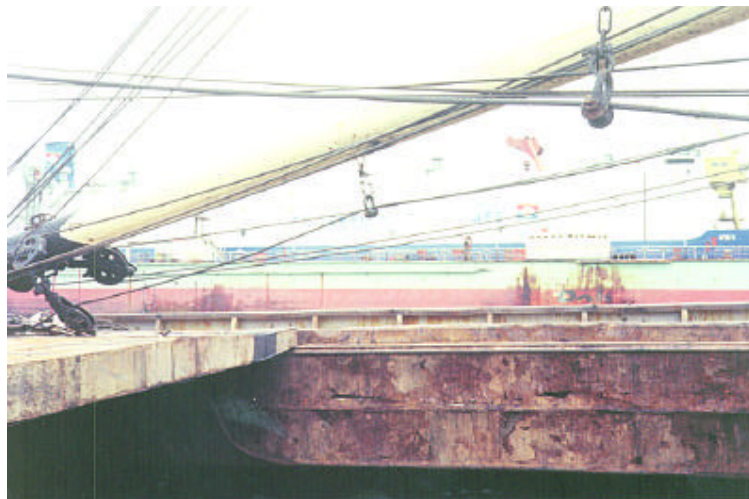
- 3.1.1** The level of wastage of under-deck stiffeners/structures may have to be established by means of thickness measurements. As mentioned previously the combination of the effects from the marine environment and the local atmosphere will give rise to high corrosion rates.
- 3.1.2** Severe corrosion of the hatch coaming from inside and of under deck girders may occur due to difficult access for maintenance of the protective coating. This may in turn lead to fractures (See **Photograph 1**).

Photograph 1 Heavy corrosion of hatch coaming

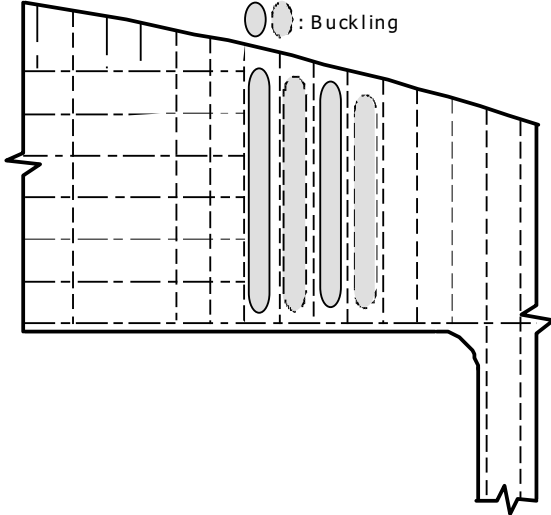
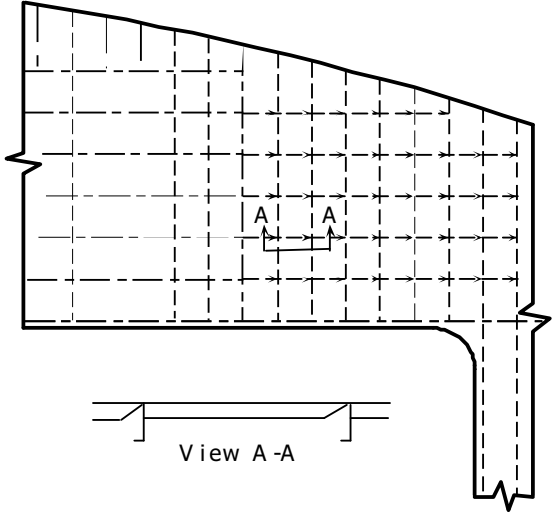
GENERAL CARGO SHIPS		Guidelines for Surveys, Assessment and Repair of Hull Structure	
Part 1	Cargo hold region	Example No.	
Area 1	Upper deck structure	1	
Detail of damage		Buckling of deck plating of transverse framing system	
<p>Sketch of damage</p>

<p>Notes on possible cause of damage</p> <ol style="list-style-type: none"> 1. Excessive compressive stress due to slamming or bow flare effect. 2. Insufficient longitudinal stiffening of deck plating. 		<p>Notes on repairs</p> <ol style="list-style-type: none"> 1. Buckled plating should be cropped and renewed. Longitudinal internal stiffeners should be provided. (Instead of longitudinal stiffeners, renewal by thicker deck plating can be accepted.) 2. Stress concentration may occur at the end of sniped stiffener resulting in fatigue fracture. For locations where high cyclic stress may occur, appropriate connection such as lug-connection should be considered.

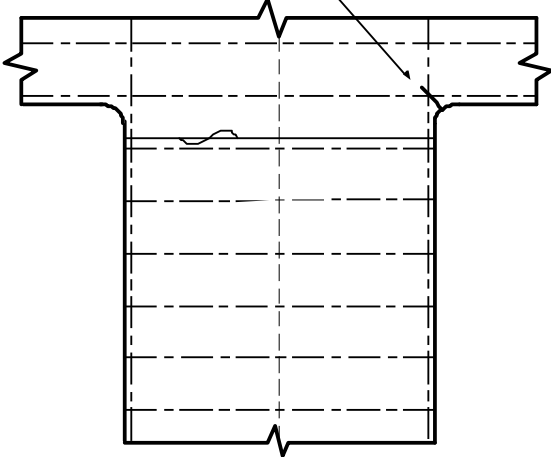
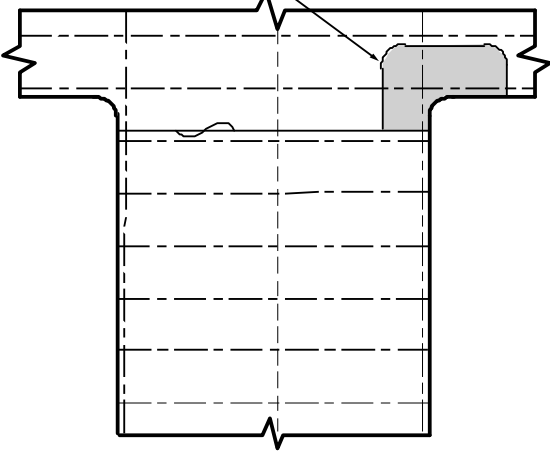
GENERAL CARGO SHIPS		Guidelines for Surveys, Assessment and Repair of Hull Structure	
Part 1	Cargo hold region	Example No.	
Area 1	Upper deck structure	2	
Detail of damage	Fractures at main cargo hatch corner		
Sketch of damage

Notes on possible cause of damage 1. Stress concentration at hatch corners, i.e. radius of corner. 2. Welded attachment of shedder plate close to edge of hatch corner. 3. Wire rope groove.		Notes on repairs 1. The corner plating in way of the fracture is to be cropped and renewed. If stress concentration is primary cause, insert plate should be of increased thickness, enhanced steel grade and/or improved geometry. Insert plate should be continued beyond the longitudinal and transverse extent of the hatch corner radius ellipse or parabola, and the butt welds to the adjacent deck plating should be located well clear of the butts in the hatch coaming. It is recommended that the edges of the insert plate and the butt welds connecting the insert plates to the surrounding deck plating be made smooth by grinding. In this respect caution should be taken to ensure that the micro grooves of the grinding are parallel to the plate edge. 2. If the cause of fracture is welded attachment of shedder plate, the deck connection should be left unwelded. 3. If the cause of the fracture is wire rope groove, replacement to the original design can be accepted.

Sketch of repair Insert plate of enhanced steel grade and increased thickness

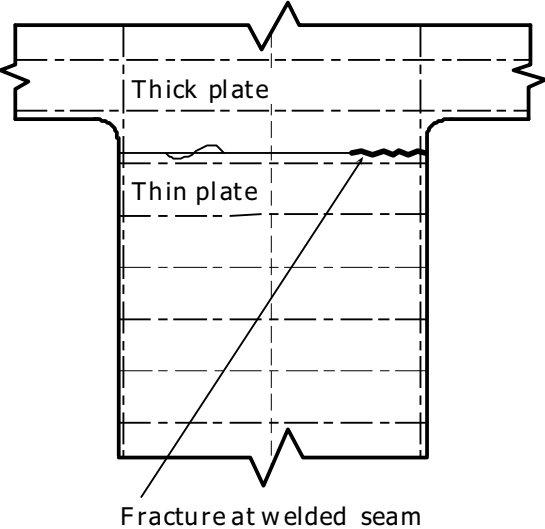
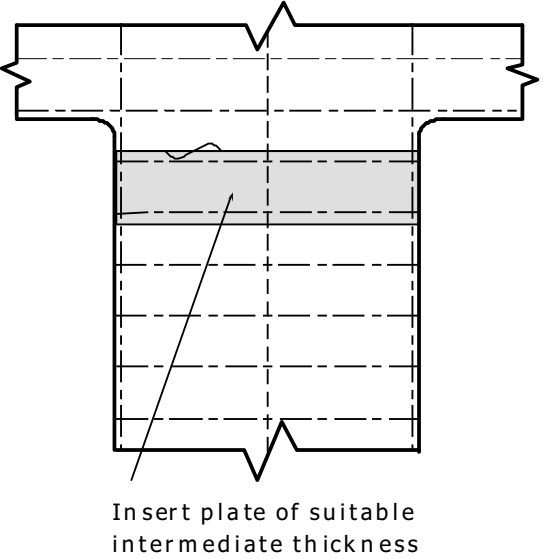
GENERAL CARGO SHIPS		Guidelines for Surveys, Assessment and Repair of Hull Structure	
Part 1	Cargo hold region	Example No.	
Area 1	Upper deck structure	3-a	
Detail of damage		Fracture of welded seam between thick plate and thin plate at cross deck	
Sketch of damage		Sketch of repair

Notes on possible cause of damage		Notes on repairs	
<ol style="list-style-type: none"> 1. Stress concentration created by abrupt change in deck plating thickness. 2. In-plane bending in cross deck strip due to torsional (longitudinal) movements of ship sides. 3. Welded seam not clear of tangent point of hatch corner. 		<ol style="list-style-type: none"> 1. Insert plate of intermediate thickness is recommended. 2. Smooth transition between plates (beveling) should be considered.

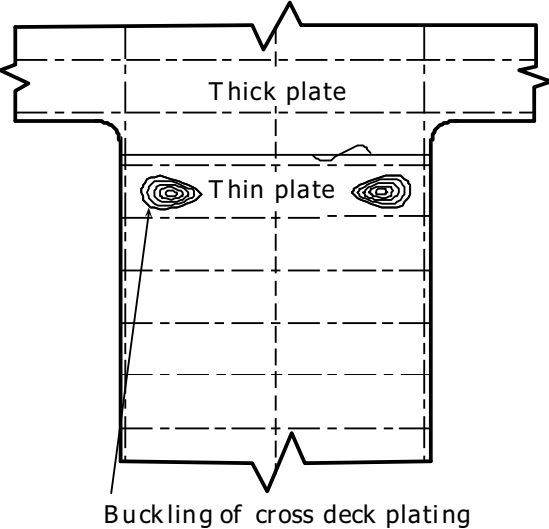
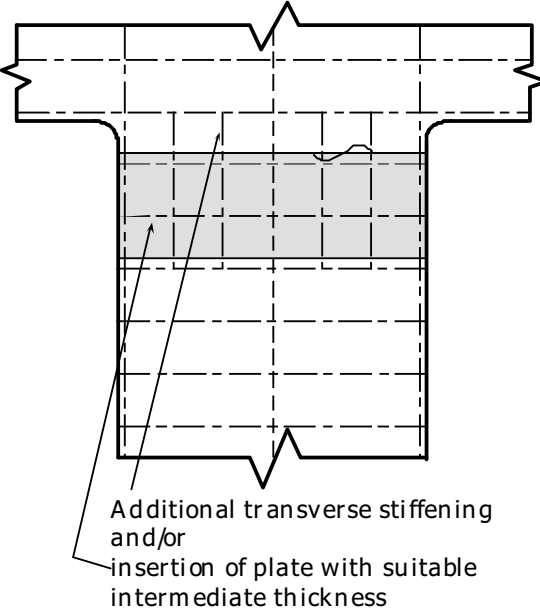
GENERAL CARGO SHIPS		Guidelines for Surveys, Assessment and Repair of Hull Structure	
Part 1	Cargo hold region	Example No.	
Area 1	Upper deck structure	3-b	
Detail of damage		Plate buckling in thin plate near thick plate at cross deck	
Sketch of damage		Sketch of repair

<p>Notes on possible cause of damage</p> <ol style="list-style-type: none"> 1. In-plane bending of cross deck strip due to torsional (longitudinal) movement of ship sides, often in combination with 2. corrosion. <p>Insufficient transverse stiffening.</p>		<p>Notes on repairs</p> <ol style="list-style-type: none"> 1. Transverse stiffeners extending from hatch sides towards centerline at least 10% of breadth of hatch, and/or increased plate thickness in the same area.

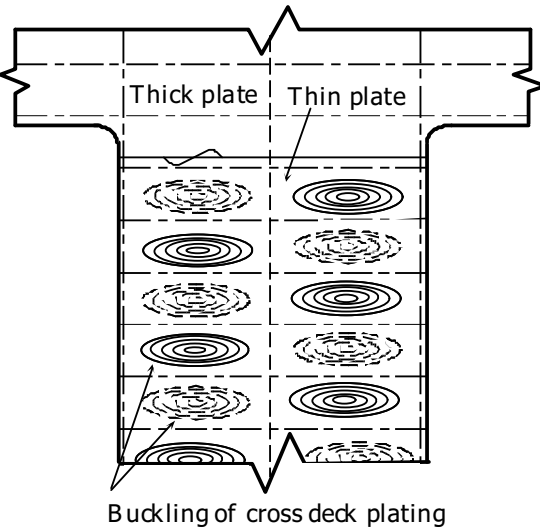
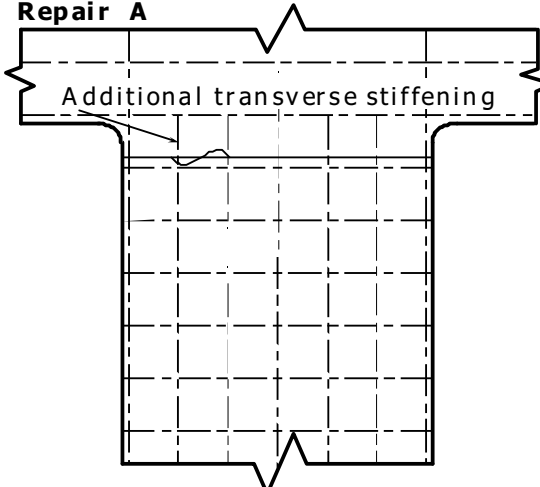
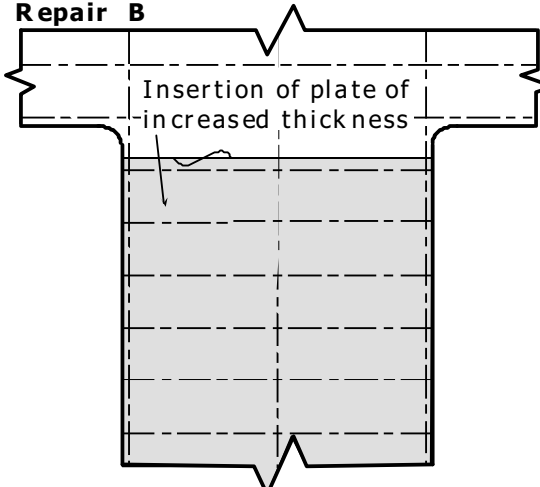
GENERAL CARGO SHIPS		Guidelines for Surveys, Assessment and Repair of Hull Structure	
Part 1	Cargo hold region	Example No.	
Area 1	Upper deck structure	3-c	
Detail of damage		Overall buckling of cross deck plating	
<p>Sketch of damage</p>

<p>Notes on possible cause of damage</p> <ol style="list-style-type: none"> 1. Transverse compression of deck due to sea load. 2. Insufficient transverse stiffening. 		<p>Notes on repairs</p> <ol style="list-style-type: none"> 1. Repair A Plating of original thickness in combination with additional transverse stiffening. 2. Repair B Insertion of plating of increased thickness.

<p>Sketch of repair</p> <p>Repair A</p>

<p>Repair B</p>

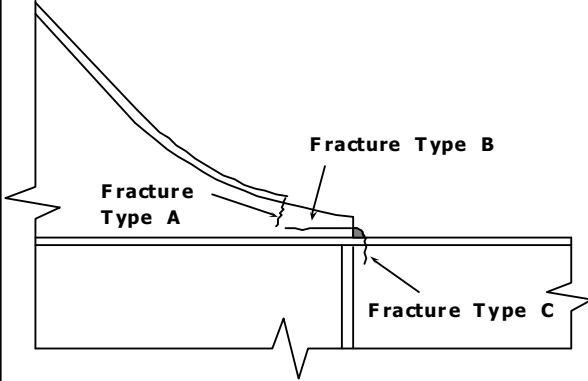
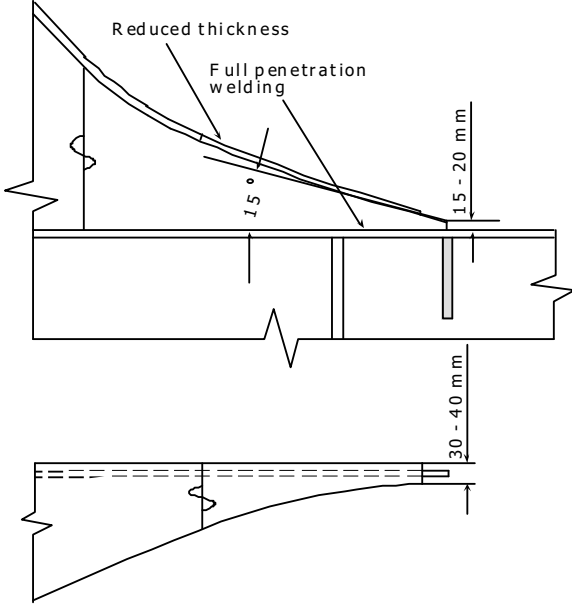
GENERAL CARGO SHIPS		Guidelines for Surveys, Assessment and Repair of Hull Structure	
Part 1	Cargo hold region	Example No.	
Area 1	Upper deck structure	5-b	
Detail of damage	Fractures in continuous longitudinal hatch coaming extension bracket		
Sketch of damage	Sketch of repair

<p>Notes on possible cause of damage</p> <ol style="list-style-type: none"> 1. Flange force at the end of the flange too high due to insufficient tapering (Fracture Type A, propagating in the web). 2. Shear force in the web plate too high due to insufficient reduction of the web height at the end (Fracture Type B, propagating in the web at the undercut or HAZ of the fillet weld). 3. Insufficient support of the extension bracket below the deck (Fracture Type C, starting from undercut or HAZ of the fillet weld and propagating in the deck plating). 	<p>Notes on repairs</p> <ol style="list-style-type: none"> 1. Extend the extension bracket as long as possible to arrange a gradual transition. 2. Reduce the web height at the end of the bracket; in case of high stress areas grind smooth the transition to the deck plating welding. 3. Reduce the cross sectional area of the flange at the end as far as possible. 4. Provide longitudinal structure in way of the web of the extension bracket to the next transverse structure or provide a new transverse structure.

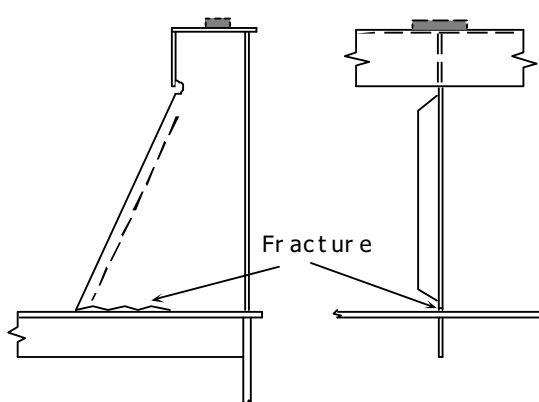
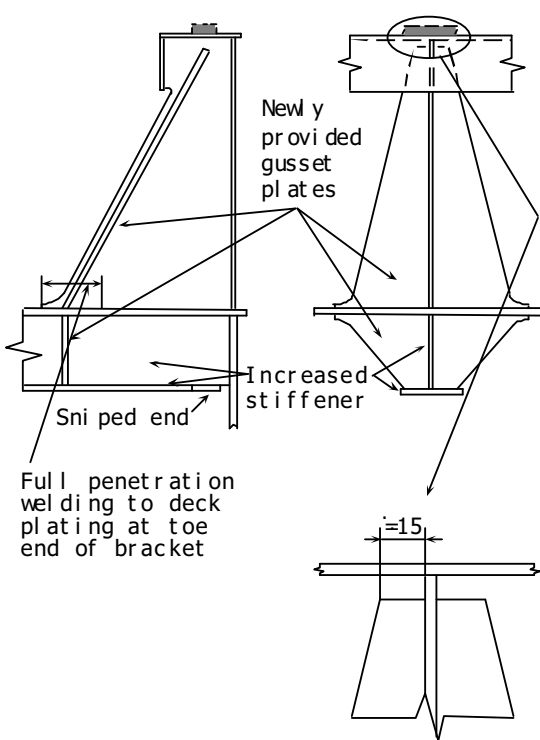
GENERAL CARGO SHIPS		Guidelines for Surveys, Assessment and Repair of Hull Structure	
Part 1	Cargo hold region	Example No.	
Area 1	Upper deck structure	6	
Detail of damage		Fractures in web of transverse hatch coaming stay	
Sketch of damage		Sketch of repair

<p>Notes on possible cause of damage</p> <p>1. Insufficient consideration of the horizontal friction forces in way of the resting pads for hatch cover.</p>		<p>Notes on repairs</p> <p>1. Modification of the design of the hatch coaming stay.</p> <p>2. Full penetration welding between gusset plates and deck plating.</p> <p>3. Strengthening and continuation of the structure below the deck.</p> <p>4. Use pads with smaller coefficient of friction.</p>

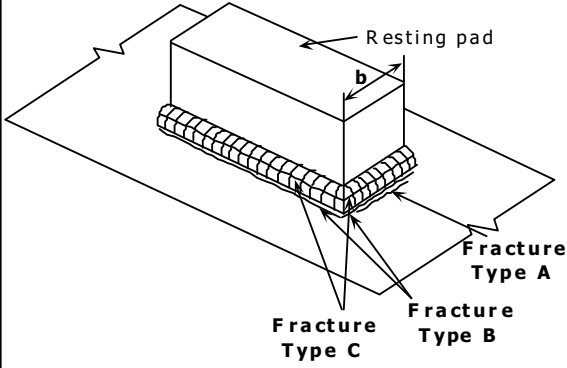
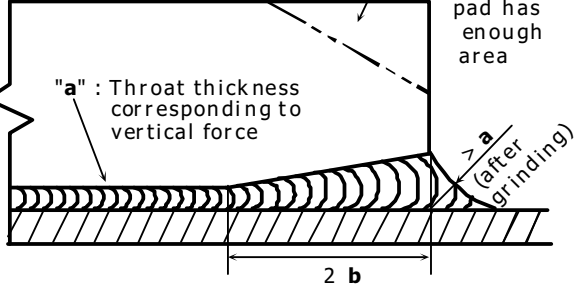
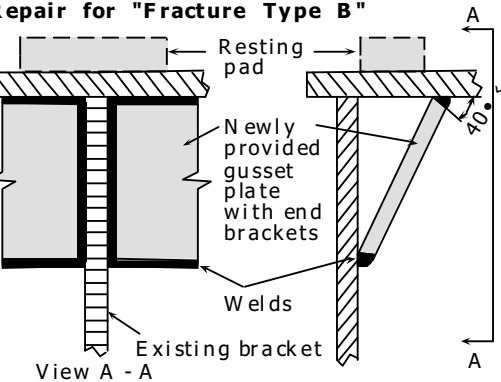
GENERAL CARGO SHIPS		Guidelines for Surveys, Assessment and Repair of Hull Structure	
Part 1	Cargo hold region	Example No.	
Area 1	Upper deck structure	8	
Detail of damage	Fractures in hatch coaming top plate around resting pad		
Sketch of damage		Sketch of repair

<p>Fracture Type A: Starting in way of the undercut or HAZ of the transverse fillet weld and propagating in the top plating.</p> <p>Fracture Type B: Starting in way of the undercut or HAZ of the longitudinal fillet weld and propagating in the top plating.</p> <p>Fracture Type C: Starting and propagating in fillet weld</p>		<p>Repair for "Fracture Type A" Note: Cut, if the pad has enough area</p>

<p>Notes on possible cause of damage</p> <ol style="list-style-type: none"> Fracture Type A: Inappropriate transition from the hatch coaming top plating to the resting pad in respect to longitudinal stresses. Fracture Type B: Insufficient support of the resting pad below the top plating. Fracture Type C: Insufficient throat thickness of the fillet weld in relation to the vertical forces.

<p>Repair for "Fracture Type B"</p>

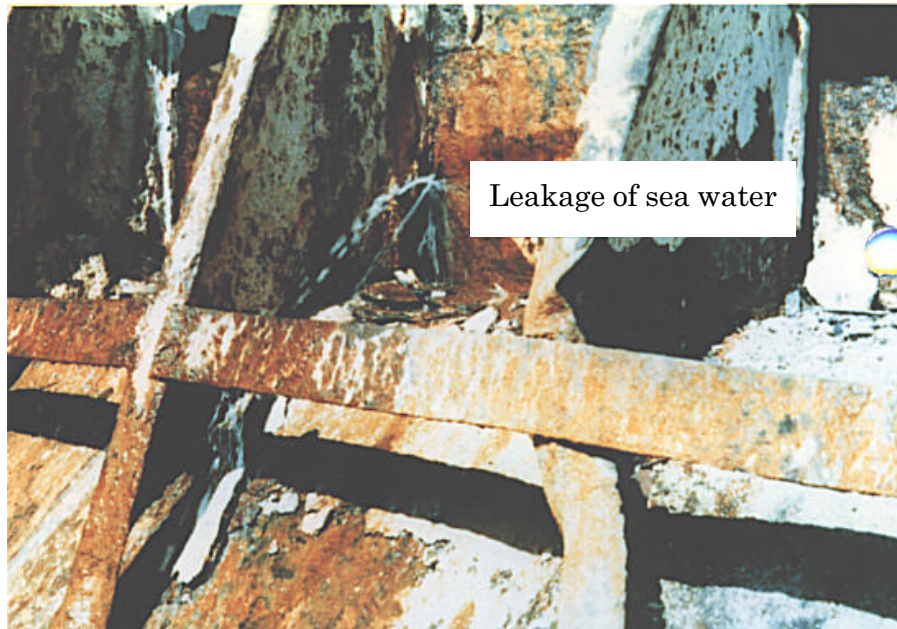
Photograph Leakage from side shell plating due to heavy corrosion

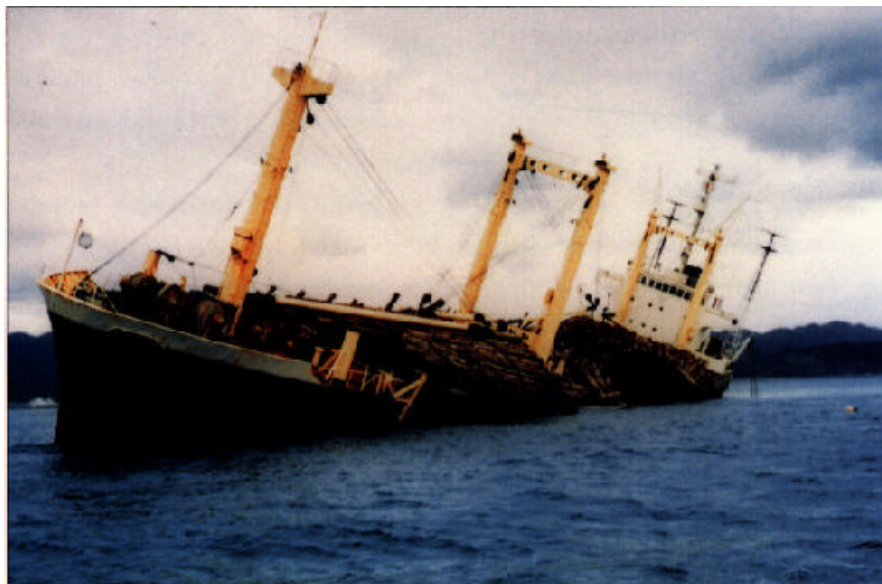
Photograph 2 Timber carrier listing due to ingress of water

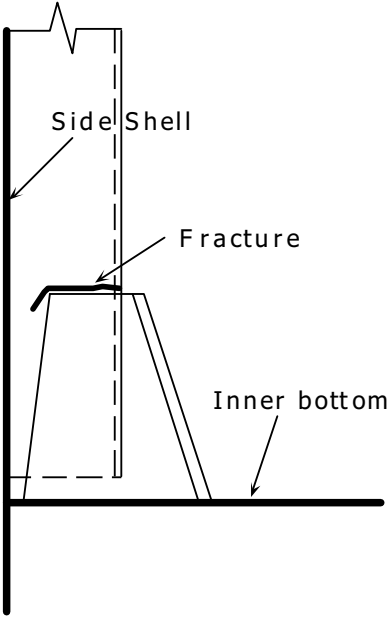
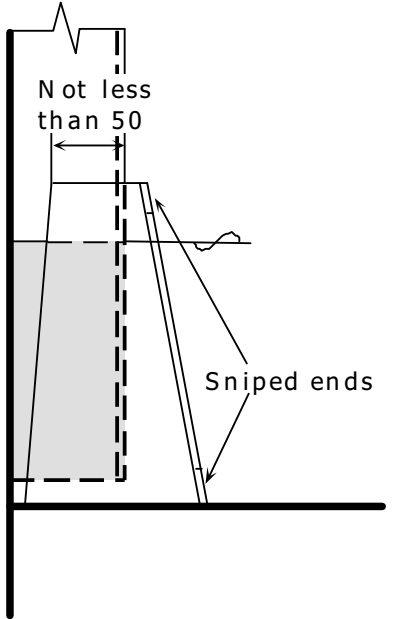
GENERAL CARGO SHIPS		Guidelines for Surveys, Assessment and Repair of Hull Structure	
Part 1	Cargo hold region	Example No.	
Area 2	Side structure	1	
Detail of damage		Fracture in side shell frame at lower bracket	
<p>Sketch of damage</p>

<p>Notes on possible cause of damage</p> <p>1. This type of damage is caused due to stress concentration.</p>		<p>Notes on repairs</p> <p>1. For small fractures, e. g. hairline fractures, the fracture can be veed-out, welded up, ground, examined by NDT for fractures, and rewelded.</p> <p>2. For larger/significant fractures consideration is to be given to cropping and partly renewing/ renewing the frame brackets. If renewing the brackets, end of frames can be sniped to soften them.</p> <p>3. If felt prudent, soft toes are to be incorporated at the boundaries of the bracket to the inner bottom plating.</p>

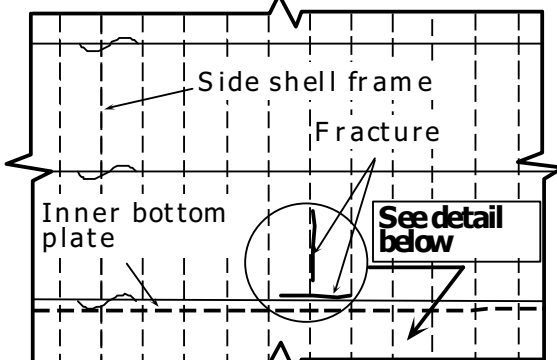
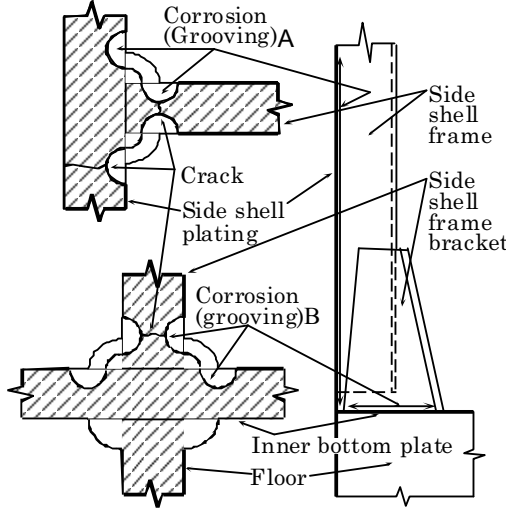
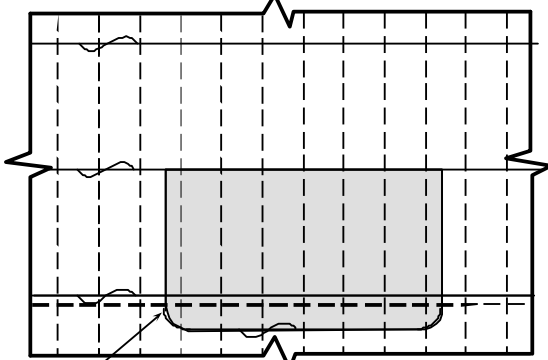
GENERAL CARGO SHIPS		Guidelines for Surveys, Assessment and Repair of Hull Structure	
Part 1	Cargo hold region	Example No.	
Area 2	Side structure	2	
Detail of damage		Fractures in side shell frame/lower bracket and side shell plating near tank top	
<p>Sketch of damage</p>

<p>Part renewal including side shell frames and inner bottom plating, as found necessary</p>	
<p>Notes on possible cause of damage</p> <ol style="list-style-type: none"> 1. Fracture in side shell plating along side shell frame: Heavy corrosion (grooving) along side shell frame (See A). 2. Fracture in side shell plating along tank top: Heavy corrosion (grooving) along tank top (See B) resulting detachment of side shell frame bracket from inner bottom plating. 		<p>Notes on repairs</p> <ol style="list-style-type: none"> 1. Sketch of repair applies when damage extends over several frames. 2. Isolated fractures may be repaired by veeing-out and rewelding. 3. Isolated cases of grooving may be repaired by build up of welding.

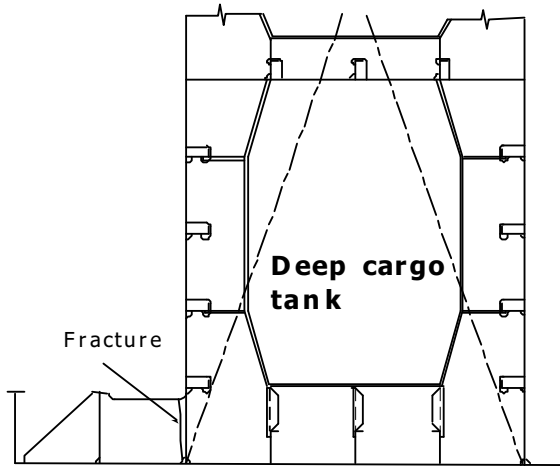
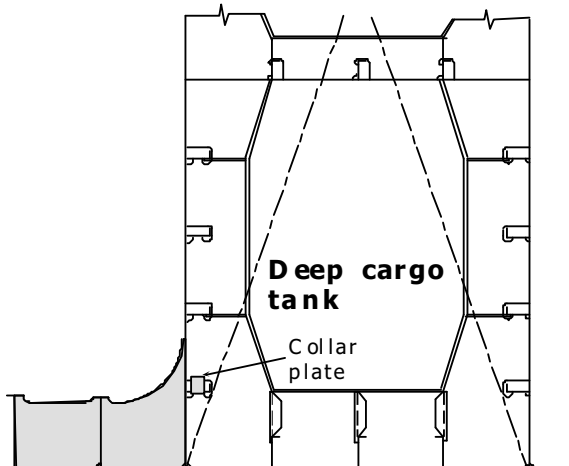
GENERAL CARGO SHIPS		Guidelines for Surveys, Assessment and Repair of Hull Structure	
Part 1	Cargo hold region	Example No.	
Area 2	Side structure	6	
Detail of damage		Fractures in way of continuation/extension brackets at the end of deep cargo tank	
<p>Sketch of damage</p>

<p>Notes on possible cause of damage</p> <p>1. Damage caused by stress concentration leading to fatigue fracture on side shell. This will be exacerbated because of the greater flexibility of the ordinary hold structure in relation to the deep cargo tank structure.</p>		<p>Notes on repairs</p> <p>1. The fractured shell plate is to be cropped and part renewed as necessary. 2. Brackets should be modified.</p>

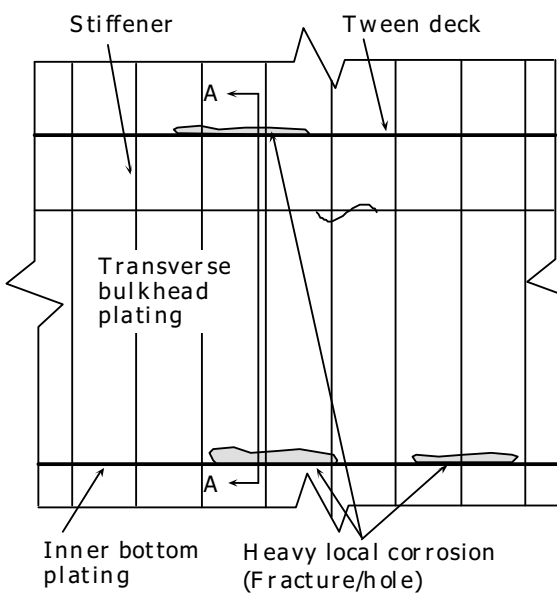
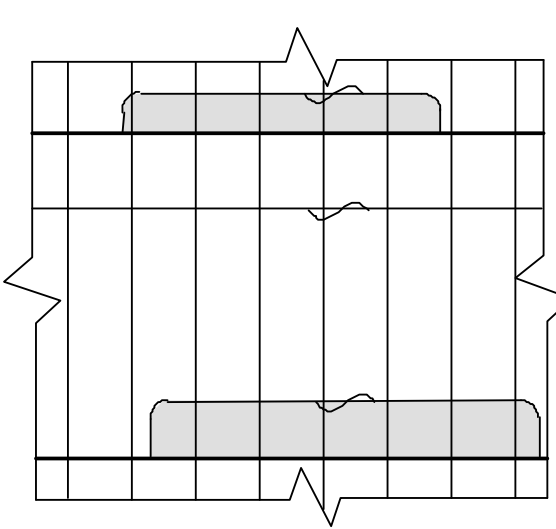
GENERAL CARGO SHIPS		Guidelines for Surveys, Assessment and Repair of Hull Structure	
Part 1	Cargo hold region	Example No.	
Area 3	Transverse bulkhead structure	1	
Detail of damage		Corrosion along inner bottom or tween deck plating	
<p>Sketch of damage</p>

<p>Notes on possible cause of damage</p> <ol style="list-style-type: none"> Heavy corrosion including grooving along inner bottom plating or tween deck due to poor drainage. 		<p>Notes on repairs</p> <ol style="list-style-type: none"> The extent of the renewal should be determined carefully. If the renewal plate (original thickness) is welded to thin plate (corroded plate), it may cause stress concentration and cause fracture. Protective coating should be applied.

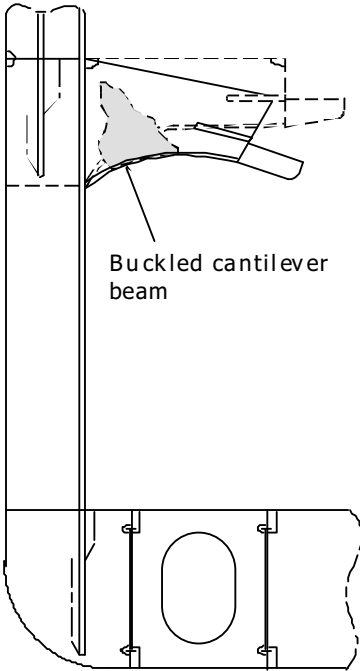
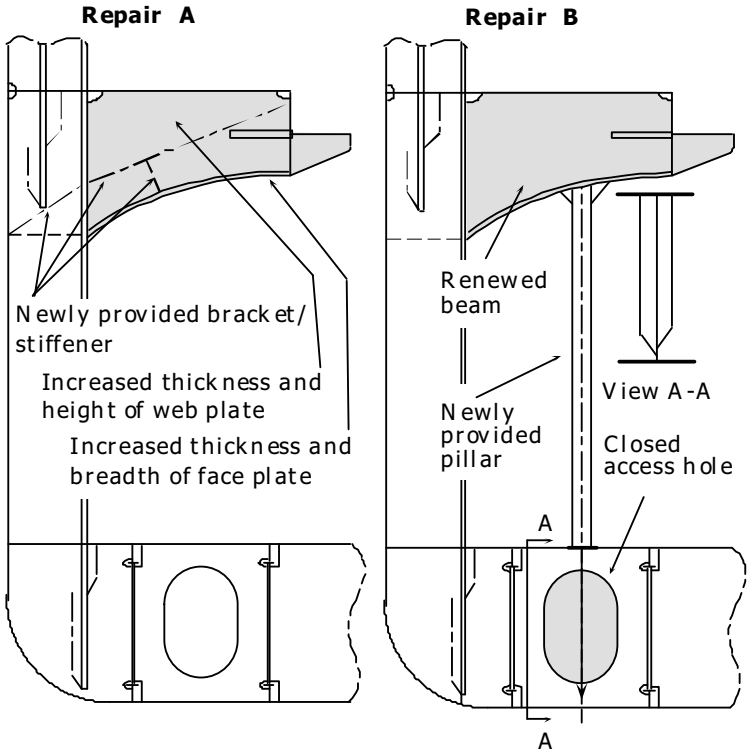
<p>Buckled cantilever beam</p>

<p>Repair A</p> <p>Newly provided bracket/stiffener</p> <p>Increased thickness and height of web plate</p> <p>Increased thickness and breadth of face plate</p> <p>Repair B</p> <p>Renewed beam</p> <p>Newly provided pillar</p> <p>View A-A</p> <p>Closed access hole</p>	
<p>Notes on possible cause of damage</p> <p>1. Poor design, overloading and/or excessive inertia force caused in heavy weather.</p>		<p>Notes on repairs</p> <p>1. The affected structures are to be cropped and renewed.</p> <p>2. Repair A: Reinforcement should be considered by increased scantlings of beam and/or additional stiffeners.</p> <p>3. Repair B: Pillars may be provided for reinforcement subject to the approval of the owner. In such a case, reinforcement of the floor under the pillar should be considered. (In the above example, access hole was closed.)</p>

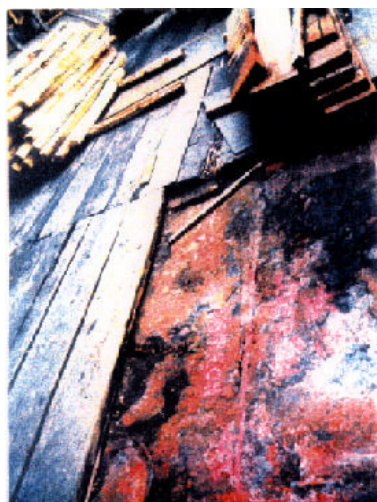
Photograph 1
Fractured inner bottom plating due to heavy corrosion on both sides

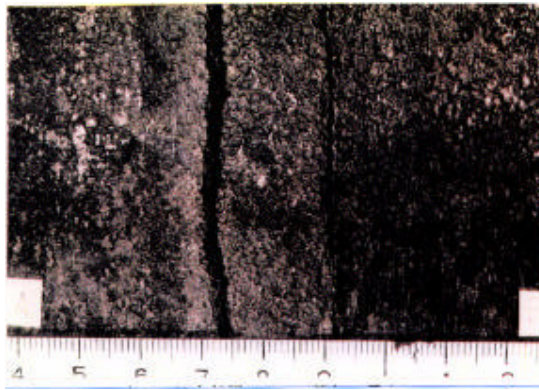
Photograph 2
Grooving corrosion of welding
of bottom plating

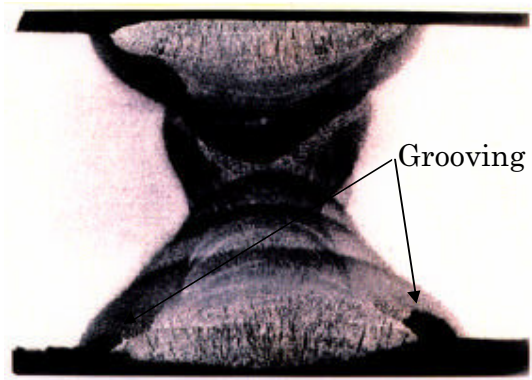
Photograph 3
Section of the grooving shown
in Photograph 2

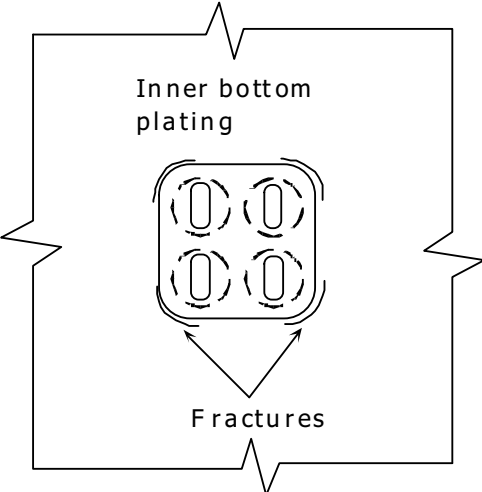
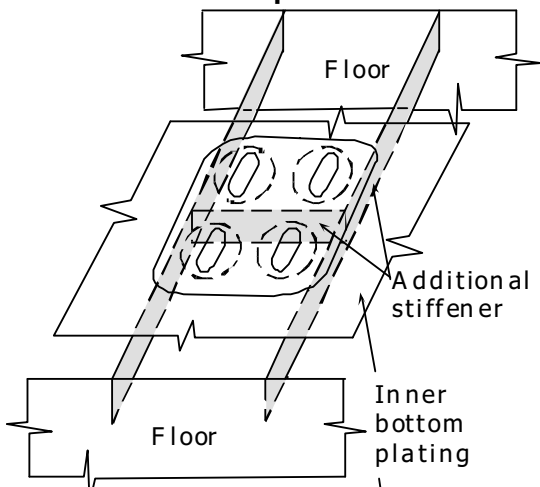
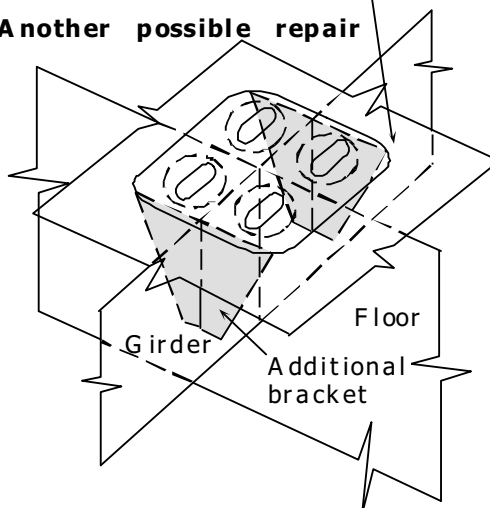
<p>Notes on possible cause of damage</p> <p>1. Pocket is not supported correctly by floor, longitudinal and/or stiffener.</p>		<p>Notes on repairs</p> <p>1. Fractured plating should be cropped and part renewed.</p> <p>2. Adequate reinforcement should be considered.</p>

<p>Sketch of repair</p> <p>Most common repair</p>

<p>Another possible repair</p>

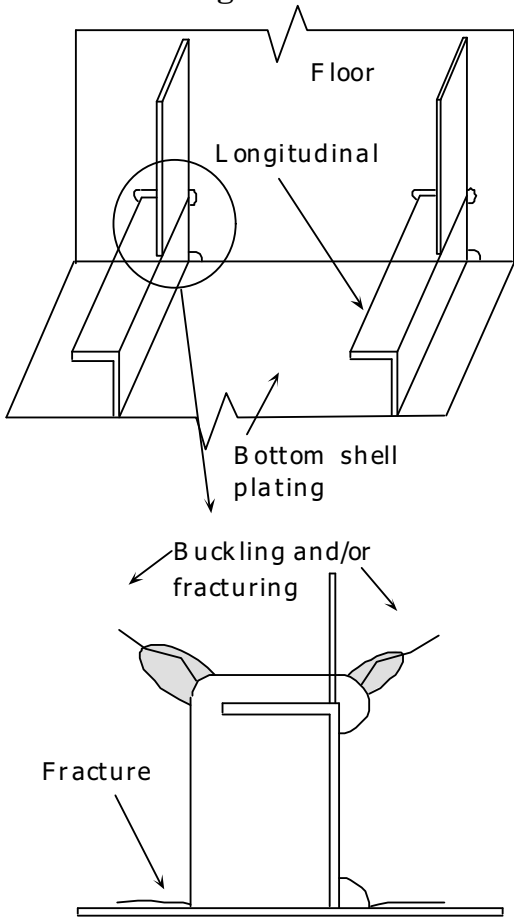
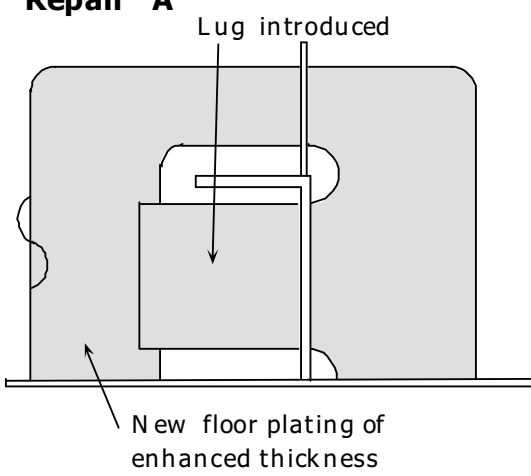
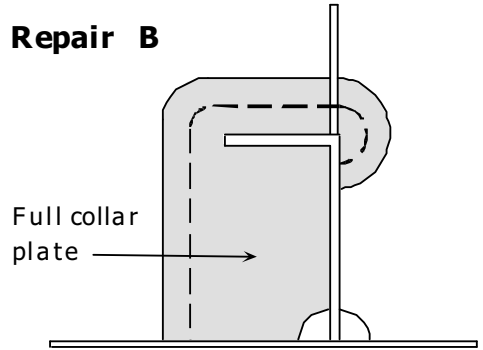
<p>Notes on possible cause of damage</p> <p>1. Damage can be caused by general levels of corrosion and presence of stress concentration associated with the presence of a cut-out.</p>		<p>Notes on repairs</p> <p>1. If fractures are significant then crop and part renew the floor plating otherwise the fracture can be veed-out and welded provided the plating is not generally corroded.</p> <p>2. Repair B is to be incorporated if the lug proves to be ineffective.</p>

<p>Note: same type of damage may occur at similar connections to inner bottom</p>		<p>Sketch of repair</p> <p>Repair A</p>

<p>Repair B</p>

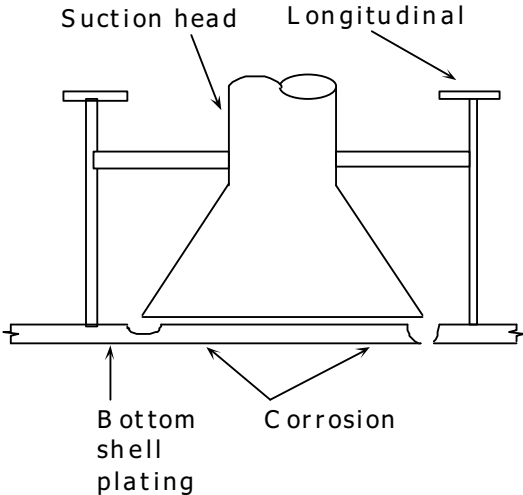
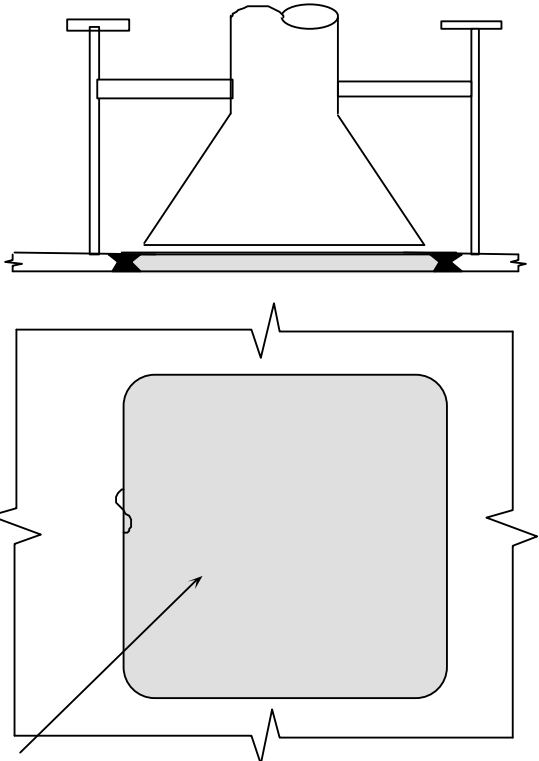
<p>1. Insert to have round corners 2. Non-destructive examination to be applied after welding based on the Society's rules</p>	
<p>Notes on possible cause of damage</p> <ol style="list-style-type: none"> High flow rate associated with insufficient corrosion prevention system. Galvanic action between dissimilar metals 		<p>Notes on repairs</p> <ol style="list-style-type: none"> Affected plating should be cropped and part renewed. Thicker plate and suitable beveling should be considered. If the corrosion is limited to a small area, i.e. pitting corrosion, repair by welding is acceptable.

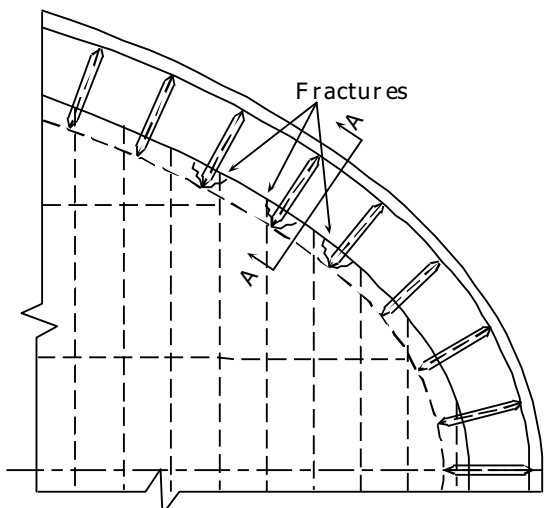
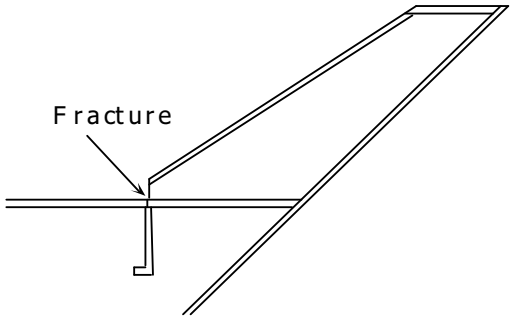
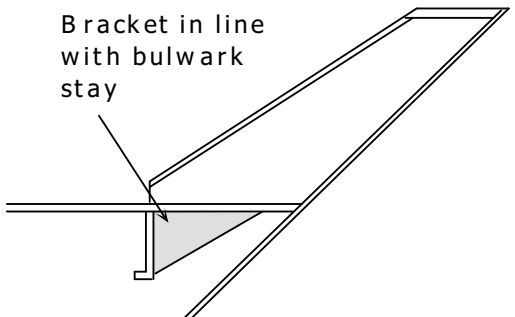
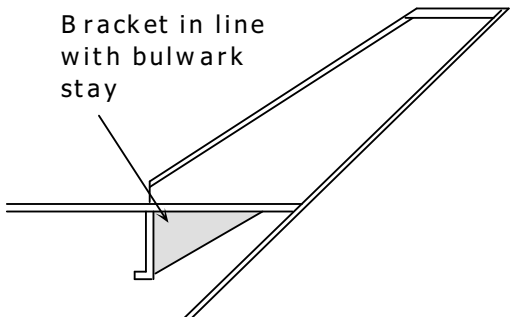
<p>Notes on possible cause of damage</p> <ol style="list-style-type: none"> 1. Bow flare effect in heavy weather. 2. Stress concentration due to poor design. 		<p>Notes on repairs</p> <ol style="list-style-type: none"> 1. Fractured deck plating should be cropped and renewed. 2. Bracket in line with the bulwark stay to be fitted to reduce stress concentration.

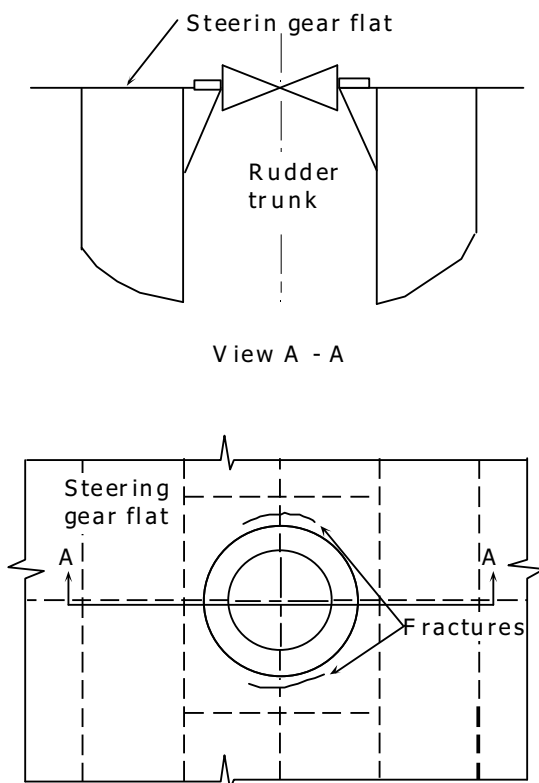
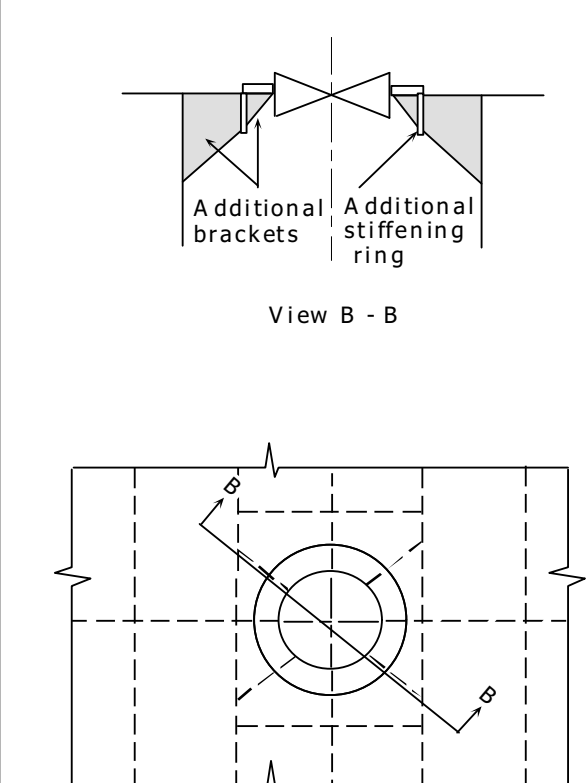
<p>View B - B</p>	
<p>Notes on possible cause of damage</p> <ol style="list-style-type: none"> Inadequate design. 		<p>Notes on repairs</p> <ol style="list-style-type: none"> Fractured plating should be cropped and renewed. Additional brackets and stiffening ring should be fitted for reinforcement.

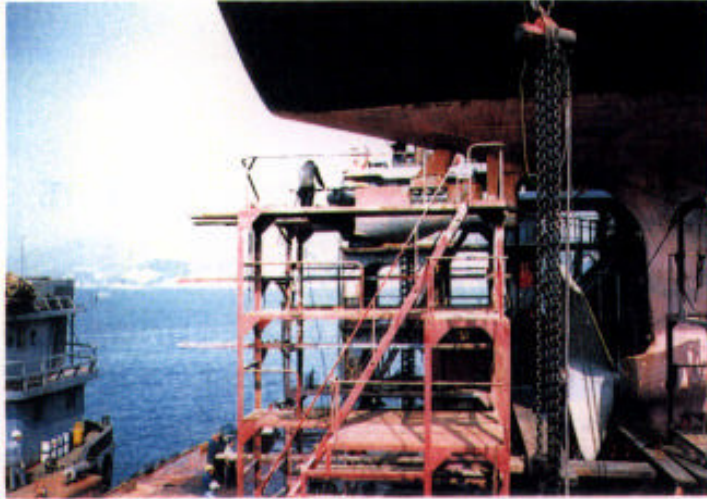
Photograph 1
Fractured rudder due to corrosion in rudder plating

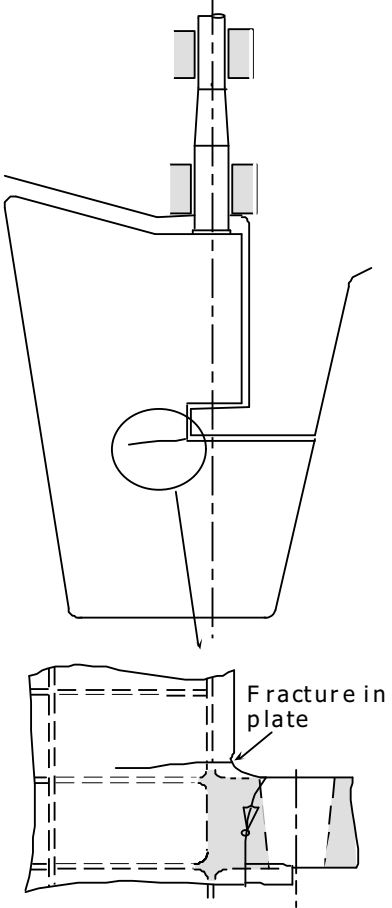
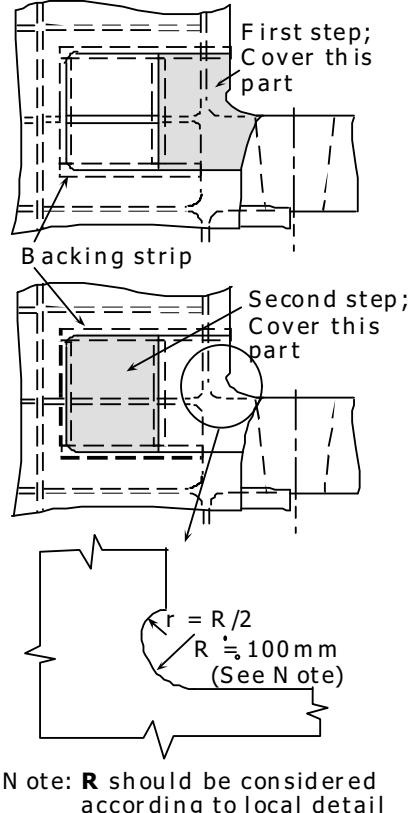
Notes on possible cause of damage		Notes on repairs	
<ol style="list-style-type: none"> 1. Stress concentration due to inadequate local design and/or fabrication notches in way of the butt weld between cast piece and plating. 		<ol style="list-style-type: none"> 1. Fractured plating is to be cut-out. 2. Internal structures are to be checked. 3. Cut-out is to be closed by an insert plating according to the sketch (welding only from one side is demonstrated). 4. Modification of the radius. 5. In case of a new cast piece, connection with the plating is to be shifted outside the high stress area.

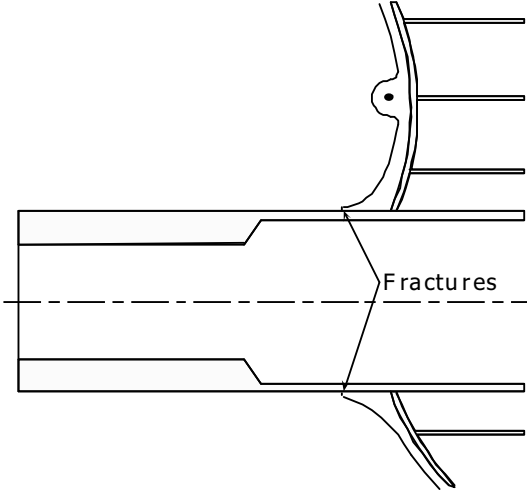
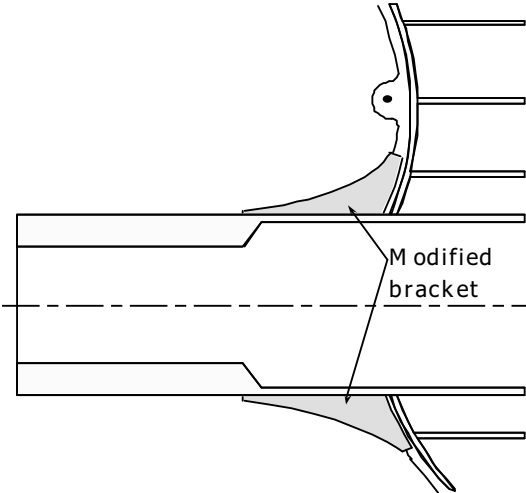
Notes on possible cause of damage 1. Fatigue fracture due to vibration.		Notes on repairs 1. Fractured tube is to be welded from both sides. 2. Brackets are to be replaced by modified brackets with soft transition.

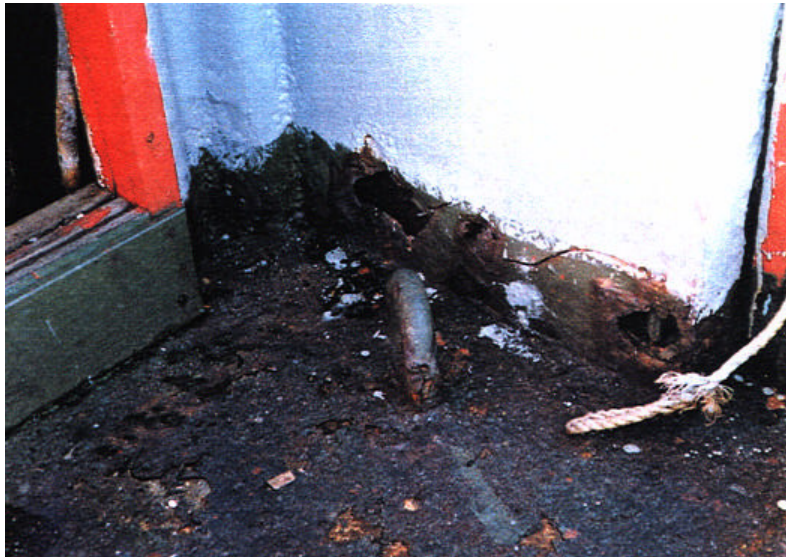
Photograph 1 Corroded accommodation house structure
