CONTAINER SHIPS

Guidelines for Surveys, Assessment and Repair of Hull Structures

First Edition
ISBN 1 85609 296 8

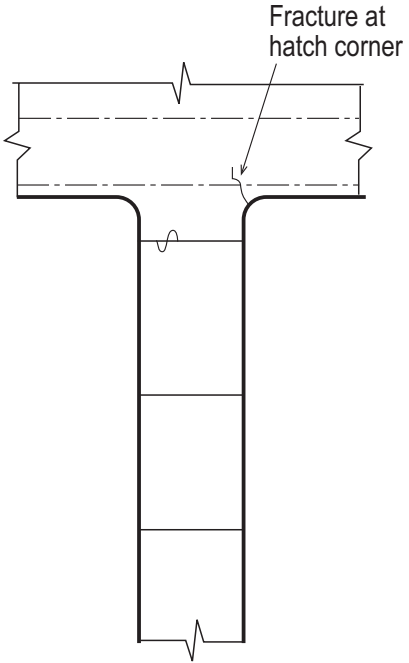
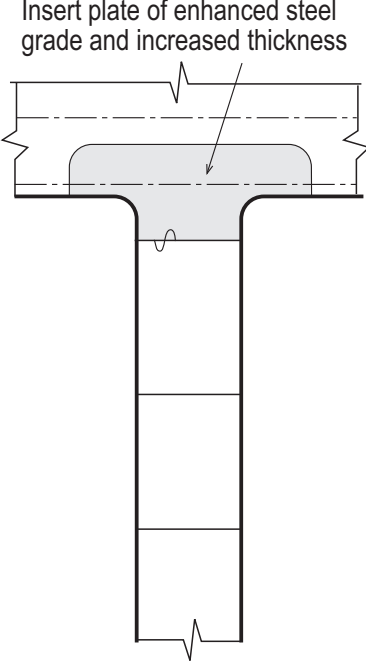
CONTAINER SHIPS		Guidelines for Surveys, Assessment and Repair of Hull Structures	
PART 1	Cargo hold region	EXAMPLE No.	
AREA 1	Upper deck structure including passageways	2-a	
Detail of damage		Fractures at main cargo hatch corner	
<p>Sketch of damage</p>

<p>Notes on possible cause of damage</p> <p>1. Stress concentration at hatch corners, i.e. radius of corner.</p>		<p>Notes on repairs</p> <p>1. The corner plating in way of the fracture is to be cropped and renewed. If stress concentration is the primary cause, insert plate should be of increased thickness, enhanced steel grade and/or improved geometry. Insert plate should be continued beyond the longitudinal and transverse extent of the hatch corner radius ellipse or parabola, and the butt welds to the adjacent deck plating should be located well clear of the butts in the hatch coaming. It is recommended that the edges of the insert plate and the butt welds connecting the insert plates to the surrounding deck plating be made smooth by grinding. In this respect caution should be taken to ensure that the micro grooves of the grinding are parallel to the plate edge.</p>

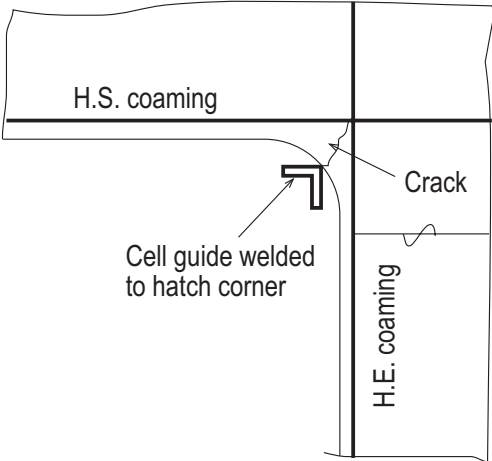
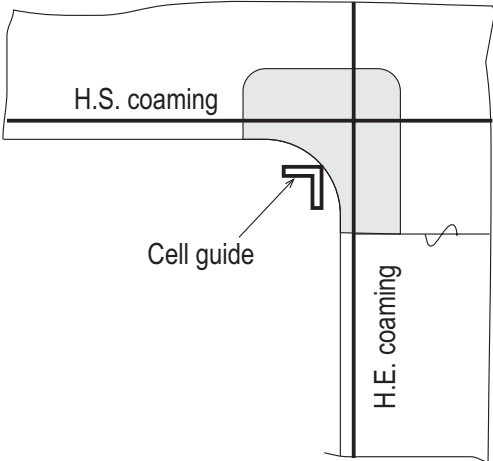
CONTAINER SHIPS		Guidelines for Surveys, Assessment and Repair of Hull Structures	
PART 1	Cargo hold region	EXAMPLE No.	
AREA 1	Upper deck structure including passageways	2-b	
Detail of damage		Fractures at main cargo hatch corner initiated from welded joint of cell guide	
<p>Sketch of damage</p>

<p>Notes on possible cause of damage</p> <ol style="list-style-type: none"> 1. In addition to high stress of hatch corner welded connection of cell guide caused stress concentration. 		<p>Notes on repairs</p> <ol style="list-style-type: none"> 1. Fractured deck plating is to be cropped and renewed. 2. Welding of cell guides to deck plating at hatch corner is to be avoided. 3. Cell guide should be connected to ship structure below deck level. 4. Alternatively an integration of the cell guide into the hatch corner could be considered.

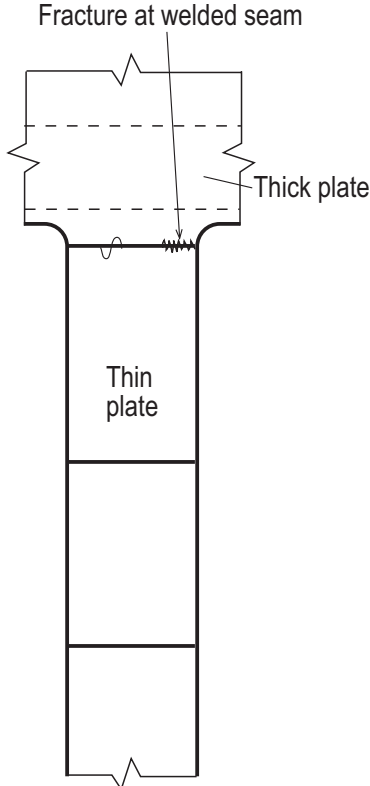
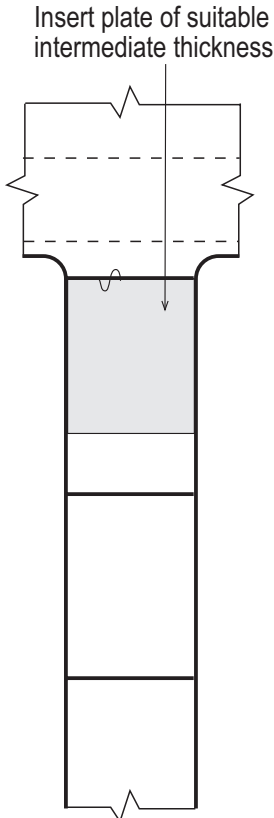
CONTAINER SHIPS		Guidelines for Surveys, Assessment and Repair of Hull Structures	
PART 1	Cargo hold region	EXAMPLE No.	
AREA 1	Upper deck structure including passageways	3-a	
Detail of damage		Fracture of welded seam between thick plate and thin plate at cross deck	
<p>Sketch of damage</p>

<p>Notes on possible cause of damage</p> <ol style="list-style-type: none"> 1. Stress concentration created by abrupt change in deck plating thickness. 2. In-plane bending in cross deck strip due to torsional (longitudinal) movements of ship sides. 3. Welded seam not clear of tangent point of hatch corner. 		<p>Notes on repairs</p> <ol style="list-style-type: none"> 1. Insert plate of intermediate thickness is recommended. 2. Smooth transition between plates (beveling) should be considered.

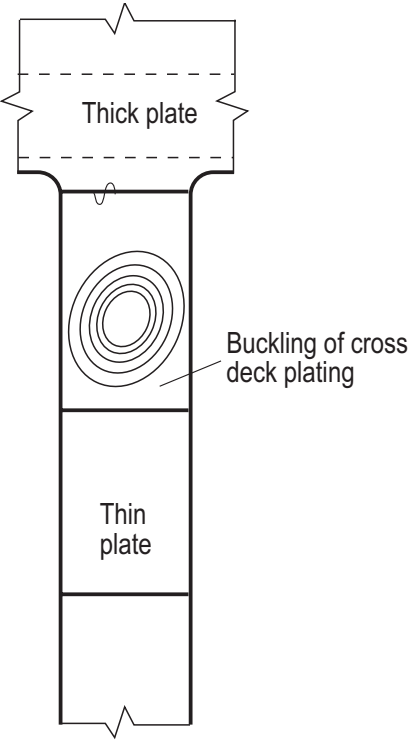
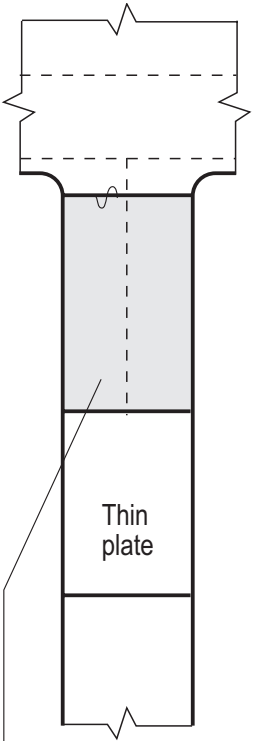
CONTAINER SHIPS		Guidelines for Surveys, Assessment and Repair of Hull Structures	
PART 1	Cargo hold region	EXAMPLE No.	
AREA 1	Upper deck structure including passageways	3-b	
Detail of damage		Plate buckling in thin plate near thick plate at cross deck	
<p>Sketch of damage</p>

<p>Additional transverse stiffening and / or insertion of plate with suitable intermediate thickness</p>	
<p>Notes on possible cause of damage</p> <ol style="list-style-type: none"> 1. In-plane shear of cross deck strip due to torsional (longitudinal) deflection of ship sides, often in combination with corrosion. 2. Insufficient transverse stiffening. 		<p>Notes on repairs</p> <ol style="list-style-type: none"> 1. Transverse stiffeners extending from hatch sides towards centerline at least 10% of breadth of hatch, and/or increased plate thickness in the same area.

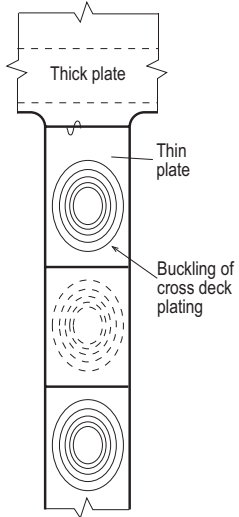
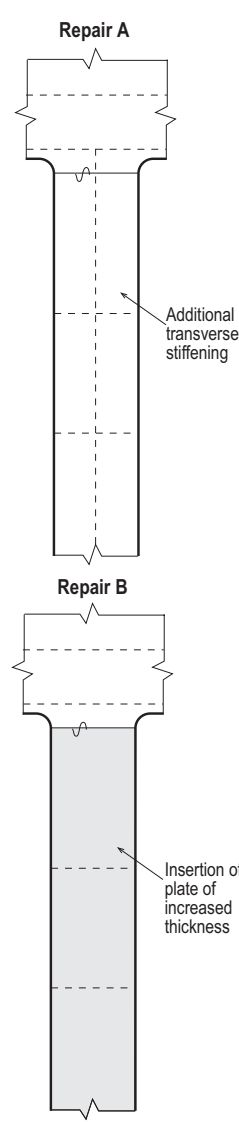
CONTAINER SHIPS		Guidelines for Surveys, Assessment and Repair of Hull Structures	
PART 1	Cargo hold region	EXAMPLE No.	
AREA 1	Upper deck structure including passageways	3-c	
Detail of damage		Overall buckling of cross deck plating	
<p>Sketch of damage</p>

<p>Notes on possible cause of damage</p> <ol style="list-style-type: none"> 1. Transverse compression of deck due to sea load. 2. Insufficient transverse stiffening. 		<p>Notes on repairs</p> <ol style="list-style-type: none"> 1. Repair A Plating of original thickness in combination with additional transverse stiffening. 2. Repair B Insertion of plating of increased thickness.

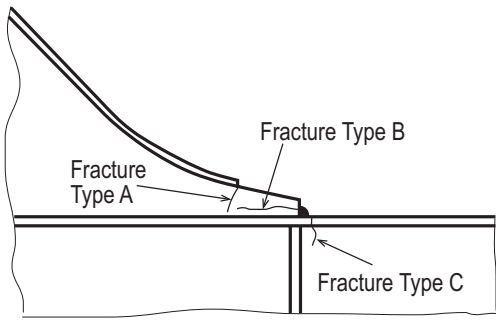
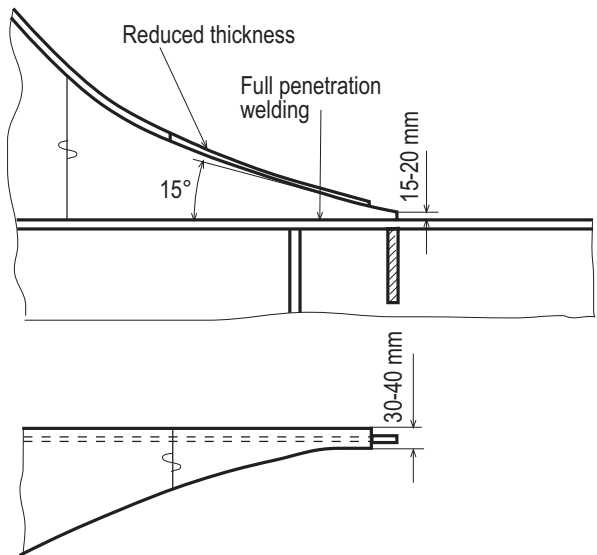
CONTAINER SHIPS		Guidelines for Surveys, Assessment and Repair of Hull Structures	
PART 1	Cargo hold region	EXAMPLE No.	
AREA 1	Upper deck structure including passageways	5	
Detail of damage		Fractures in continuous longitudinal hatch coaming extension bracket	
<p>Sketch of damage</p>

<p>Notes on possible cause of damage</p> <ol style="list-style-type: none"> 1. Flange force at the end of the flange too high due to insufficient tapering (Fracture Type A, propagating in the web). 2. Shear force in the web plate too high due to insufficient reduction of the web height at the end (Fracture Type B, propagating in the web at the undercut or HAZ of the fillet weld). 3. Insufficient support of the extension bracket below the deck (Fracture Type C, starting from undercut or HAZ of the fillet weld and propagating in the deck plating). 		<p>Notes on repairs</p> <ol style="list-style-type: none"> 1. Extend the extension bracket as long as possible to arrange a gradual transition. 2. Reduce the web height at the end of the bracket; in case of high stress areas grind smooth the transition to the deck plating welding. 3. Reduce the cross sectional area of the flange at the end as far as possible. 4. Provide longitudinal structure in way of the web of the extension bracket to the next transverse structure or provide a new transverse structure.

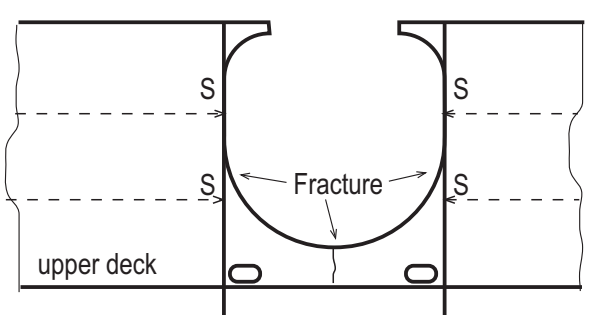
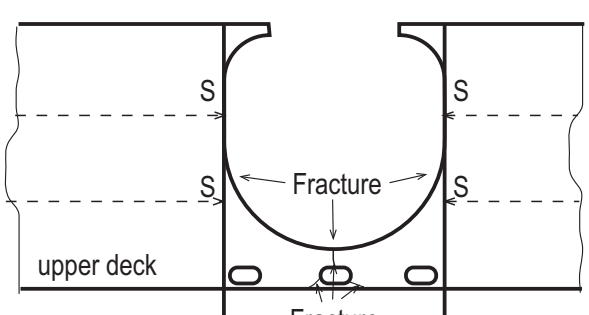
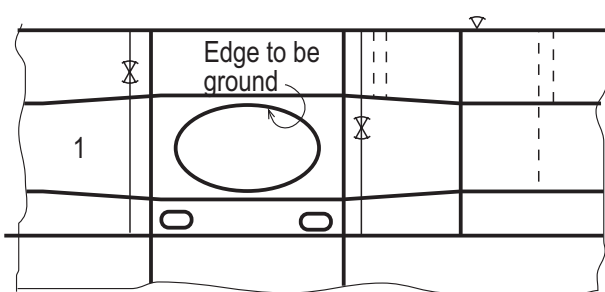
CONTAINER SHIPS		Guidelines for Surveys, Assessment and Repair of Hull Structures	
PART 1	Cargo hold region	EXAMPLE No.	
AREA 1	Upper deck structure including passageways	7	
Detail of damage		Fracture in access hole of longitudinal hatch coaming	
<p>Sketch of damage</p>

<p>Notes on possible cause of damage</p> <ol style="list-style-type: none"> 1. Coincidence of maximum increased stress due to the reduction of the hatch coaming with the metallurgical notches due to the welding seams in web and flat bar located at the same position. 		<p>Notes on repairs</p> <ol style="list-style-type: none"> 1. Hatch coaming to be continuous. 2. Access opening to be provided. 3. Drain holes to be elliptical and located above fillet weld to deck. 4. Hatch coaming stiffeners of same material as coaming

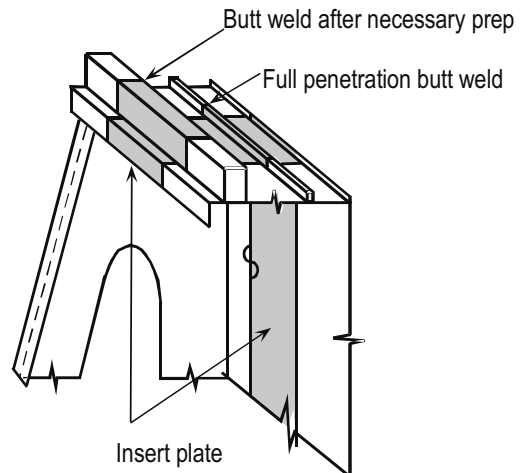
<p>Butt weld after necessary prep Full penetration butt weld Insert plate</p>	
<p>Notes on possible cause of damage</p> <ol style="list-style-type: none"> 1. Heavy weather 2. Insufficient preparation of weld of compression bar and/or rail (Although the compression bar and rail are not longitudinal strength members, they are subject to the same longitudinal stress as longitudinal members) 3. Fracture may initiate from insufficient penetration of weld of rail for hatch cover. 		<p>Notes on repairs</p> <ol style="list-style-type: none"> 1. Loading condition of the ship and proper welding procedure should be carefully considered. 2. Fractured structure is to be cropped and renewed if considered necessary (a small fracture may be veed-out and rewelded.) 3. Full penetration welding should be applied to the butt weld of compression bar and rail.

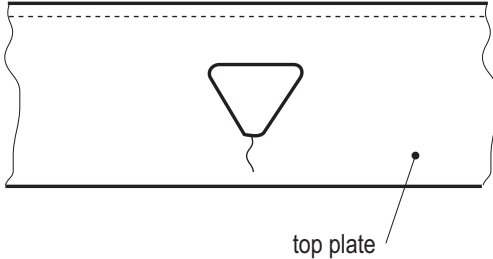
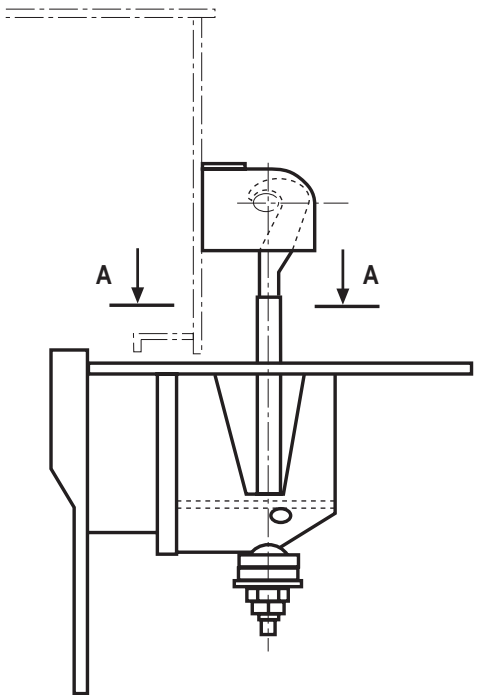
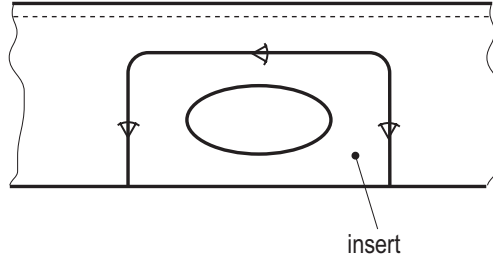
<p>Notes on possible cause of damage</p> <ol style="list-style-type: none"> 1. Stress concentration at hole 2. Inadequate design 3. Poor workmanship 		<p>Notes on repairs</p> <ol style="list-style-type: none"> 1. Damaged area to be cropped and renewed. 2. Elliptical hole to be provided for the quick acting cleat

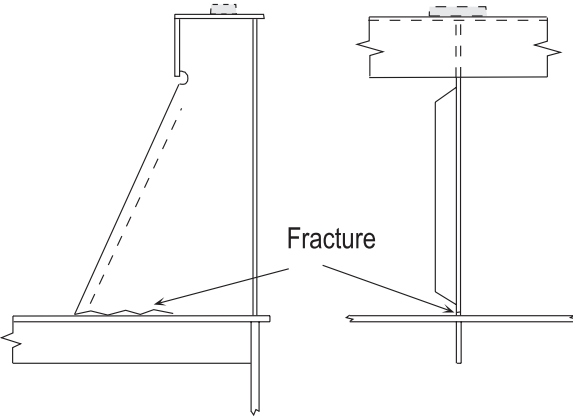
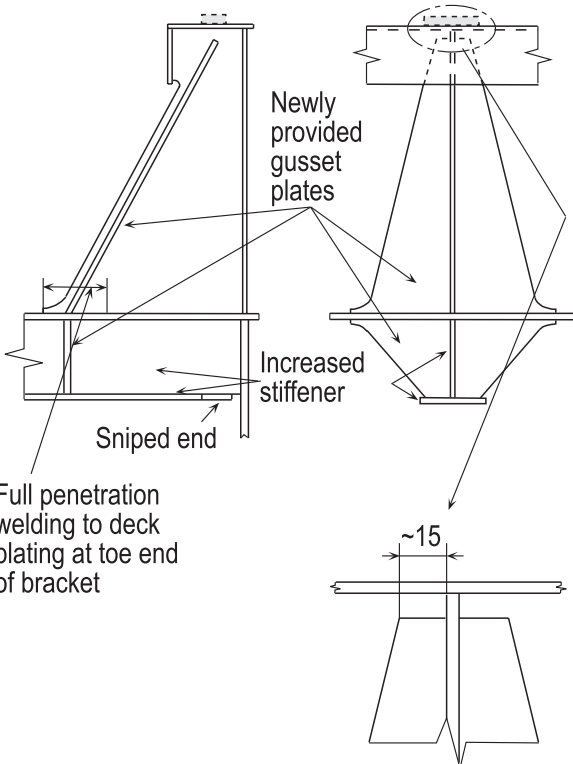
CONTAINER SHIPS		Guidelines for Surveys, Assessment and Repair of Hull Structures	
PART 1	Cargo hold region	EXAMPLE No.	
AREA 1	Upper deck structure including passageways	12	
Detail of damage		Fractures in web of transverse hatch coaming stay	
<p>Sketch of damage</p>

<p>Notes on possible cause of damage</p> <ol style="list-style-type: none"> 1. Insufficient consideration of the horizontal friction forces in way of the resting pads for hatch cover. 		<p>Notes on repairs</p> <ol style="list-style-type: none"> 1. Modification of the design of the hatch coaming stay. 2. Full penetration welding between gusset plates and deck plating. 3. Strengthening and continuation of the structure below the deck. 4. Use pads with smaller coefficient of friction.

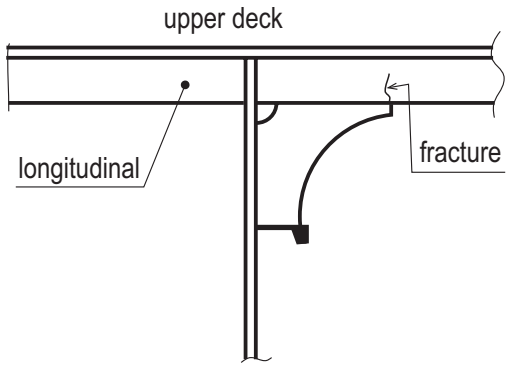
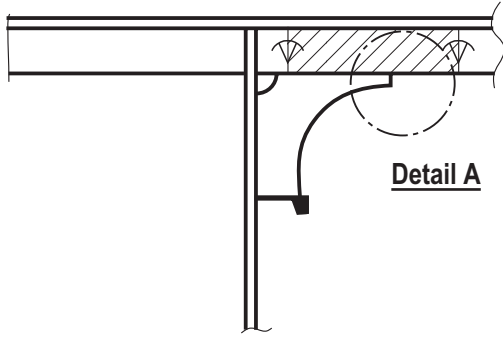
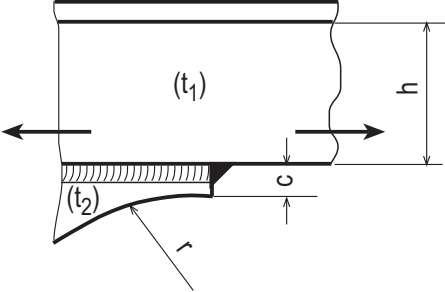
CONTAINER SHIPS		Guidelines for Surveys, Assessment and Repair of Hull Structures	
PART 1	Cargo hold region	EXAMPLE No.	
AREA 1	Upper deck structure including passageways	14	
Detail of damage		Fracture in deck longitudinal	
<p>Sketch of damage</p>

<p>$c \leq 2 t_2 \text{ max. } 25 \text{ mm}$</p> <p>$r \geq 0,5 h$</p>	
<p>Notes on possible cause of damage</p> <ol style="list-style-type: none"> 1. Stress concentration at bracket toe 2. Bracket toe too high 3. Poor workmanship 		<p>Notes on repairs</p> <ol style="list-style-type: none"> 1. Damaged area to be cropped and renewed. 2. New bracket with soft toe to be added.

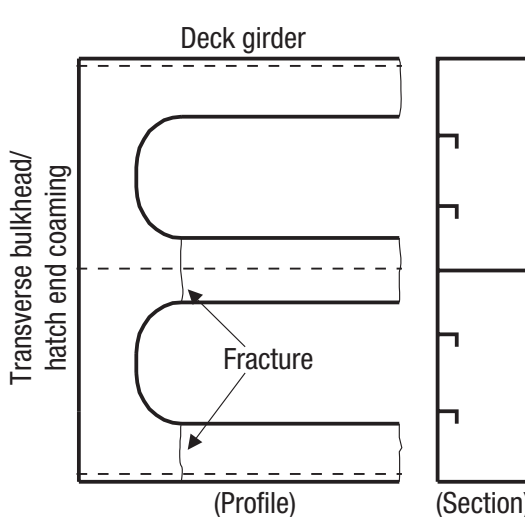
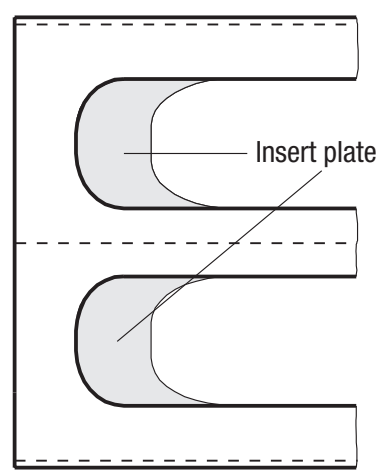
CONTAINER SHIPS		Guidelines for Surveys, Assessment and Repair of Hull Structures	
PART 1	Cargo hold region	EXAMPLE No.	
AREA 1	Upper deck structure including passageways	16	
Detail of damage		Fractures in deck girder	
<p>Sketch of damage</p>

<p>Notes on possible cause of damage</p> <ol style="list-style-type: none"> 1. Insufficient rigidity at the end of deck girder against bending and torsion 		<p>Notes on repairs</p> <ol style="list-style-type: none"> 1. Fractured parts are to be cropped and partially renewed. 2. Insert plate at the end of deck girder as shown in sketch of repair.

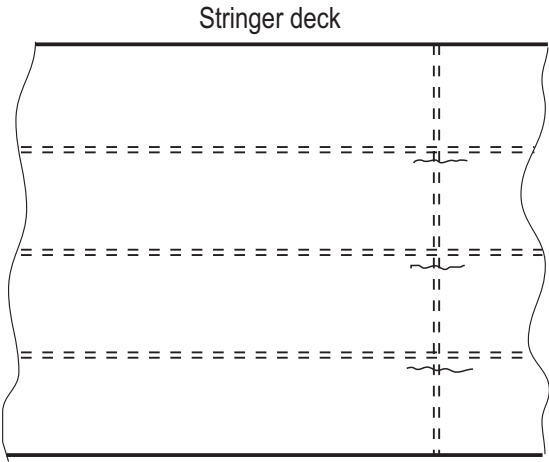
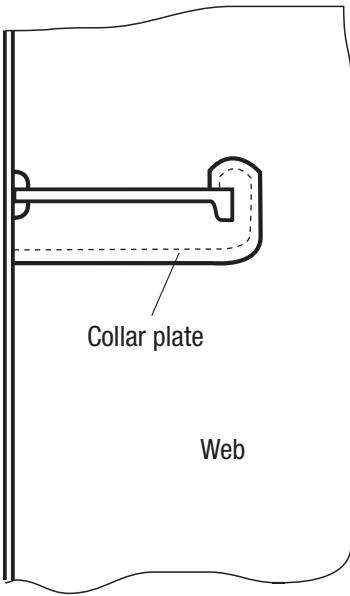
CONTAINER SHIPS		Guidelines for Surveys, Assessment and Repair of Hull Structures	
PART 1	Cargo hold region	EXAMPLE No.	
AREA 2	Side structure including tanks	6	
Detail of damage		Fractures in side wall (raised tank) at the connection of longitudinals to web of transverses	
<p>Sketch of damage</p>

<p style="text-align: center;">Collar plate</p> <p style="text-align: center;">Web</p>	
<p>Notes on possible cause of damage</p> <p>1. Damage can be caused by stress concentration leading to accelerated fatigue in this region.</p>		<p>Notes on repairs</p> <p>1. Fractured side wall plating to be cropped and renewed by insert plate.</p> <p>2. Cut-outs for longitudinals to be closed by collar plates.</p>

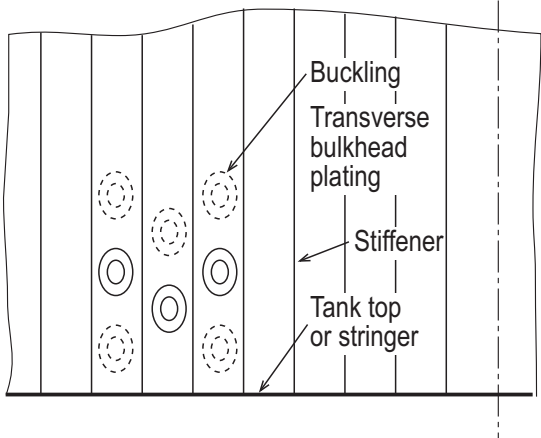
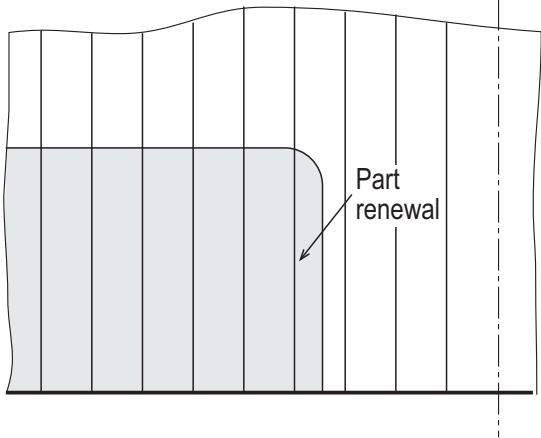
CONTAINER SHIPS		Guidelines for Surveys, Assessment and Repair of Hull Structures	
PART 1	Cargo hold region	EXAMPLE No.	
AREA 3	Transverse bulkhead structure	2	
Detail of damage		Buckling in transverse bulkhead	
<p>Sketch of damage</p>

<p>Notes on possible cause of damage</p> <ol style="list-style-type: none"> 1. Heavy general corrosion. 		<p>Notes on repairs</p> <ol style="list-style-type: none"> 1. The extent of the renewal should be determined carefully. If the renewal plating (original thickness) is welded to thin plating (corroded plating), it may cause stress concentration and fracture. 2. Protective coating should be applied.

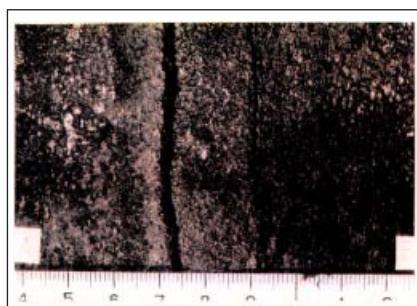
4.1.2 Severe grooving along welding of bottom plating is often found (See **Figures 1** and **2**). This grooving can be accelerated by poor maintenance of the protective coating and/or sacrificial anodes fitted to the bottom plating.

Figure 1
Grooving corrosion of welding of bottom plating

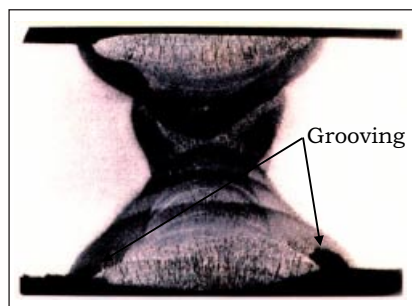
Figure 2
Section of the grooving shown in Figure 1

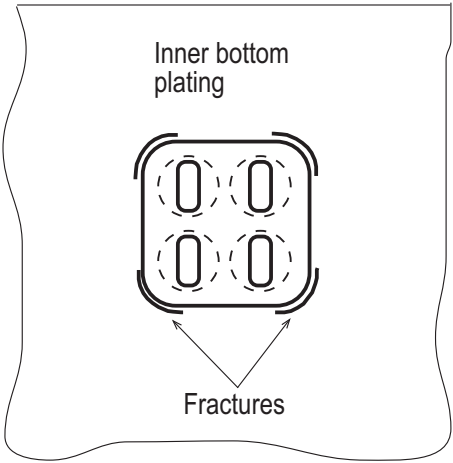
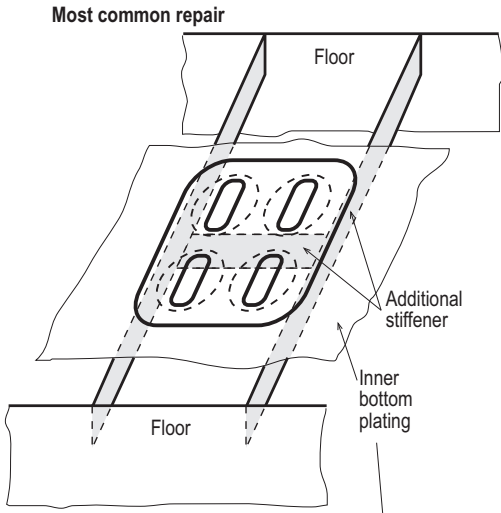
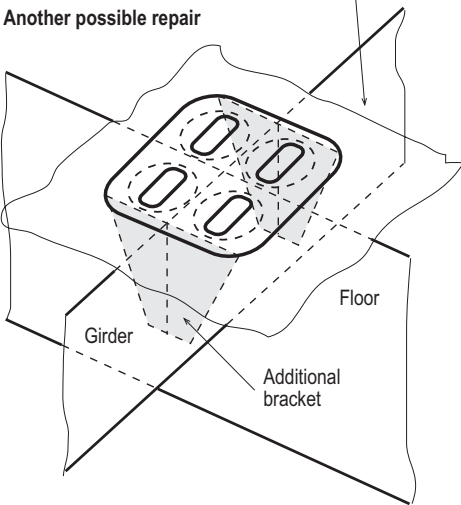
CONTAINER SHIPS		Guidelines for Surveys, Assessment and Repair of Hull Structures	
PART 1	Cargo hold region	EXAMPLE No.	
AREA 4	Double bottom tank structure	1	
Detail of damage		Fractures in inner bottom plating around container bottom pocket	
<p>Sketch of damage</p>

<p>Floor</p> <p>Girder</p> <p>Additional bracket</p>	
<p>Notes on possible cause of damage</p> <p>1. Pocket is not supported correctly by floor, longitudinal and/or stiffener.</p>		<p>Notes on repairs</p> <p>1. Fractured plating should be cropped and part renewed.</p> <p>2. Adequate reinforcement should be considered.</p>

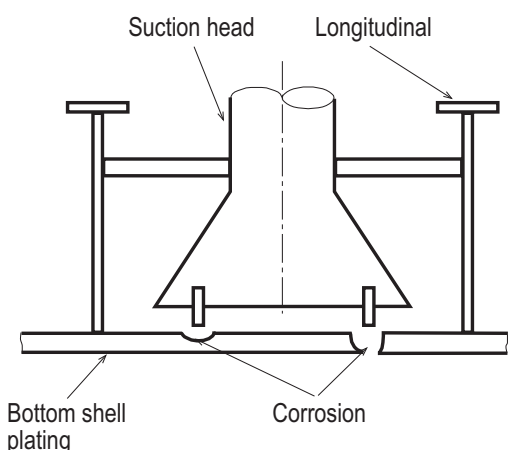
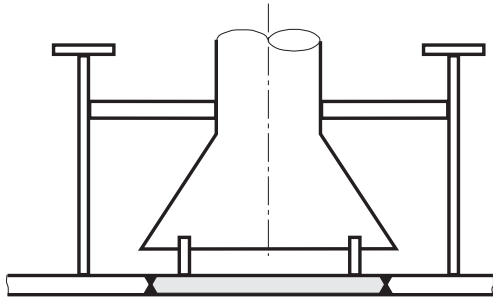
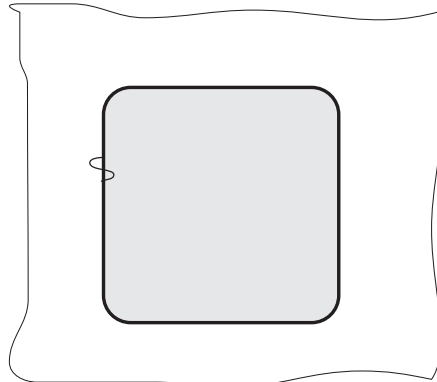
CONTAINER SHIPS		Guidelines for Surveys, Assessment and Repair of Hull Structures	
PART 1	Cargo hold region	EXAMPLE No.	
AREA 4	Double bottom tank structure	8	
Detail of damage		Corrosion in bottom plating below suction head	
<p>Sketch of damage</p>

<ol style="list-style-type: none"> 1. Insert to have round corners 2. Non-destructive examination to be applied after welding based on the Classification Society's rules 	
<p>Notes on possible cause of damage</p> <ol style="list-style-type: none"> 1. High flow rate associated with insufficient corrosion prevention system. 2. Galvanic action between dissimilar metals. 		<p>Notes on repairs</p> <ol style="list-style-type: none"> 1. Affected plating should be cropped and part renewed. Thicker plate and suitable beveling should be considered. 2. If the corrosion is limited to a small area, i. e. pitting corrosion, repair by welding is acceptable.

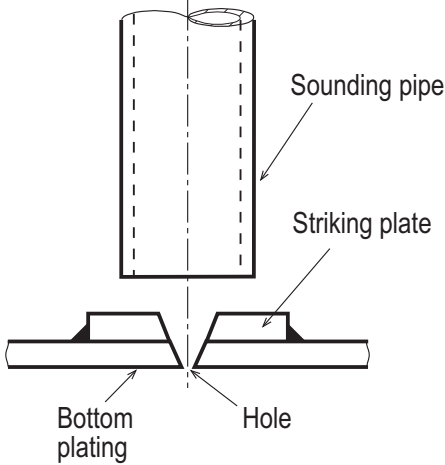
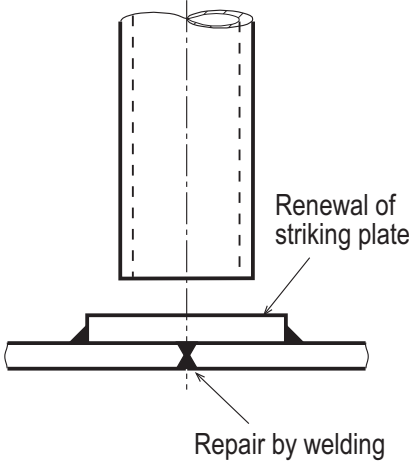
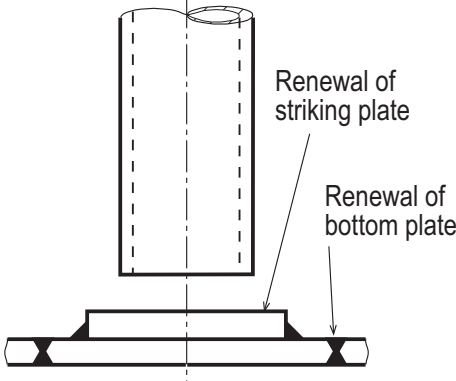
CONTAINER SHIPS		Guidelines for Surveys, Assessment and Repair of Hull Structures	
PART 1	Cargo hold region	EXAMPLE No.	
AREA 4	Double bottom tank structures	9	
Detail of damage		Corrosion in bottom plating below sounding pipe	
<p>Sketch of damage</p>

<p>Notes on possible cause of damage</p> <ol style="list-style-type: none"> 1. Accelerated corrosion of striking plate by the striking of the weight of the sounding tape. 		<p>Notes on repairs</p> <ol style="list-style-type: none"> 1. Corroded bottom plating should be welded or partly cropped and renewed if considered necessary. 2. Corroded striking plate should be renewed.

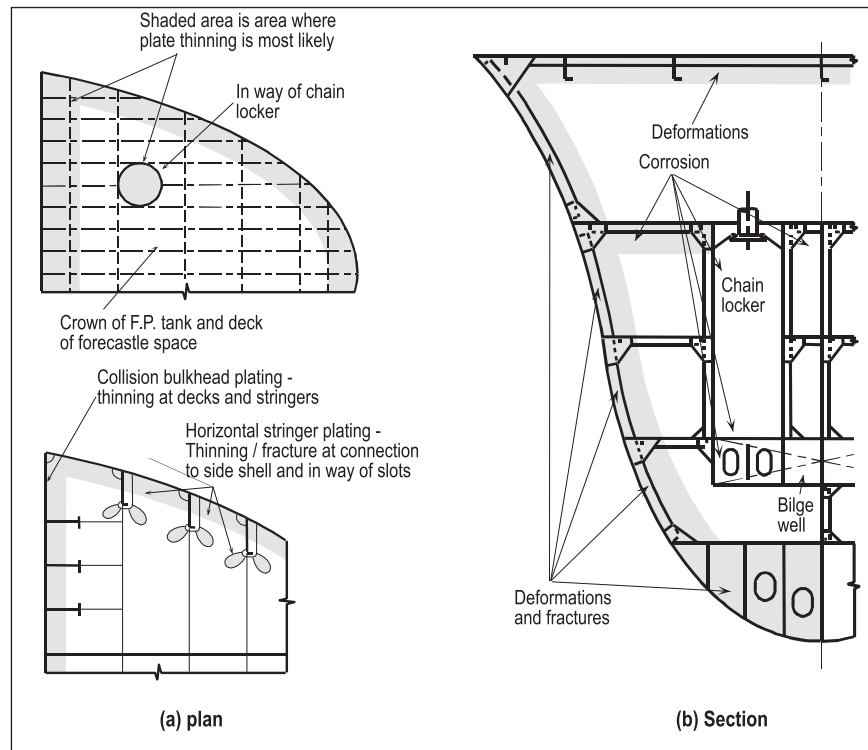
Fig 1 Fore end structure - Potential problem areas

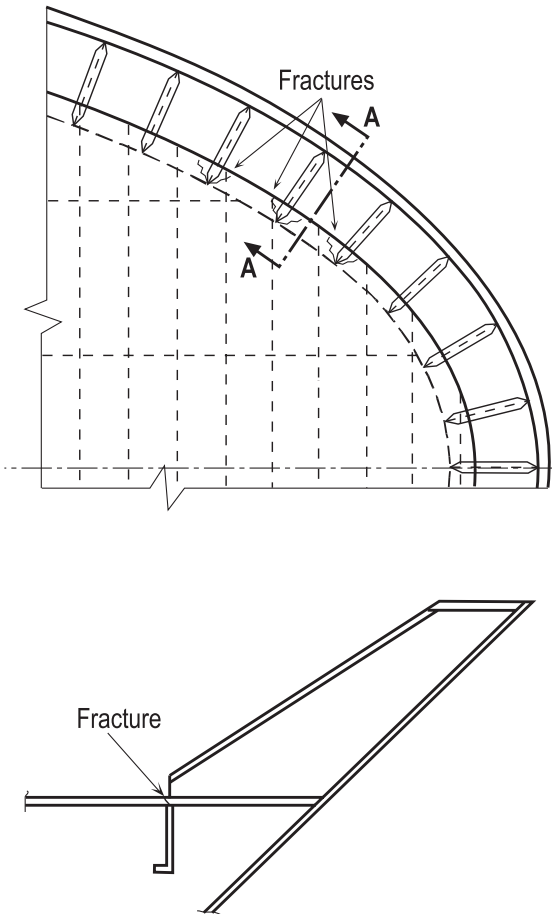
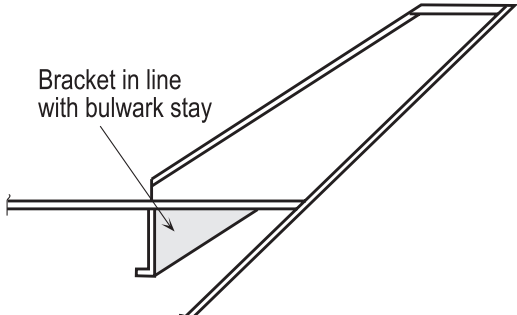
CONTAINER SHIPS		Guidelines for Surveys, Assessment and Repair of Hull Structures	
PART 2	Fore and aft end regions	EXAMPLE No.	
AREA 1	Fore end structure	2	
Detail of damage		Fractures in forecastle deck plating at the bulwark	
<p>Sketch of damage</p>

<p style="text-align: center;">View A - A</p>	
<p>Notes on possible cause of damage</p> <ol style="list-style-type: none"> 1. Bow flare effect in heavy weather. 2. Stress concentration due to poor design. 		<p>Notes on repairs</p> <ol style="list-style-type: none"> 1. Fractured deck plating should be cropped and renewed. 2. Bracket in line with the bulwark stay to be fitted to reduce stress concentration.

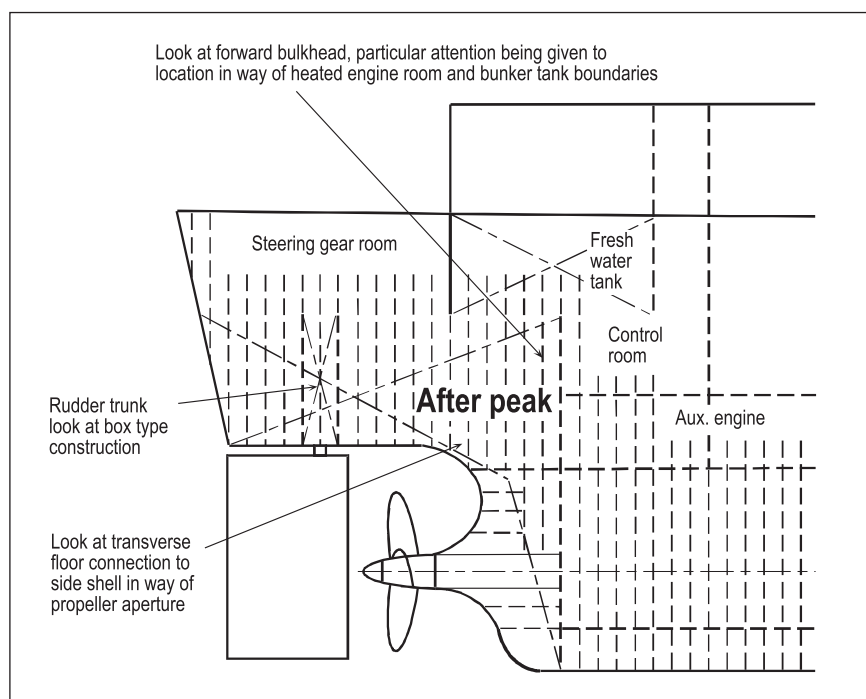
Figure 1 Aft end structure – Potential problem areas

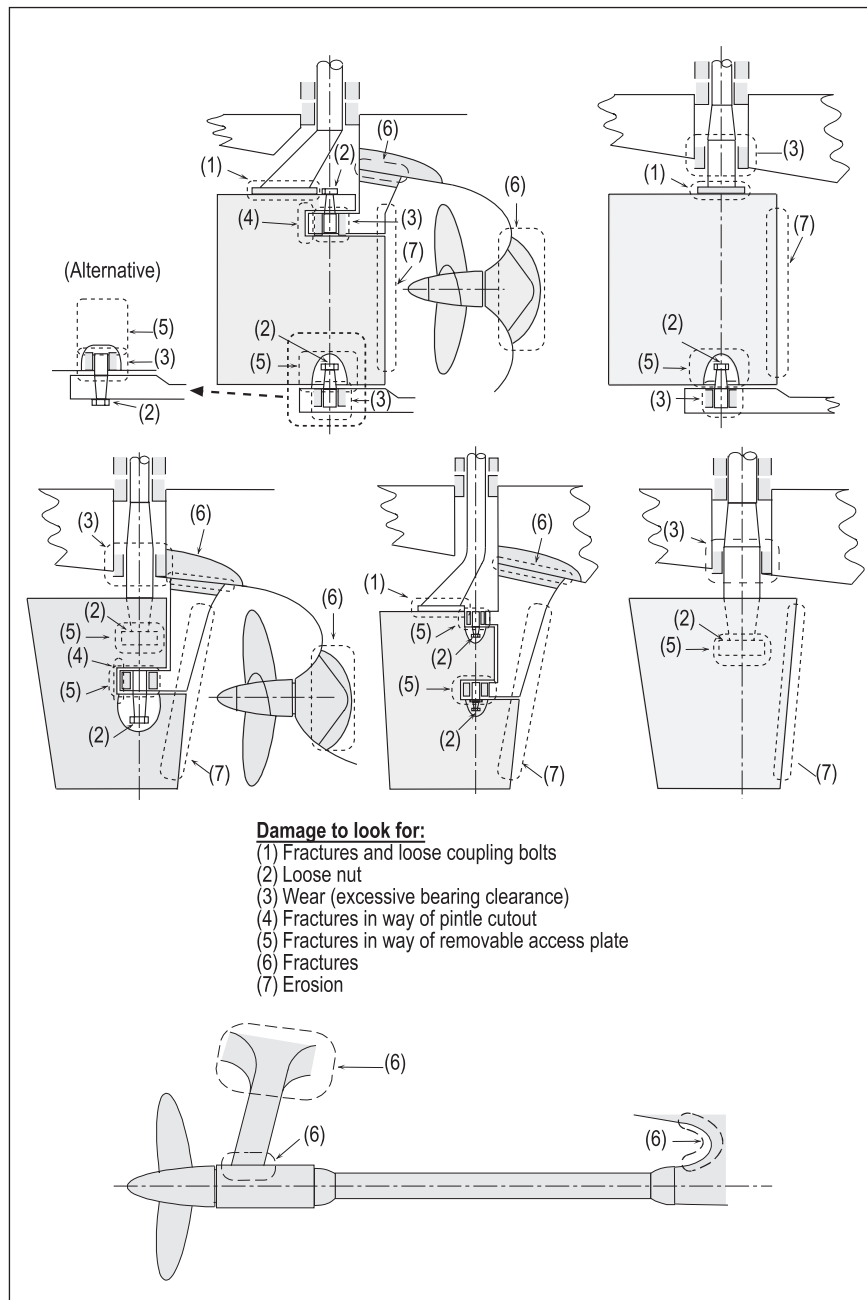
Figure 2 Potential problem areas

1.7 A summary of potential problem areas is shown in **Figure 2**.

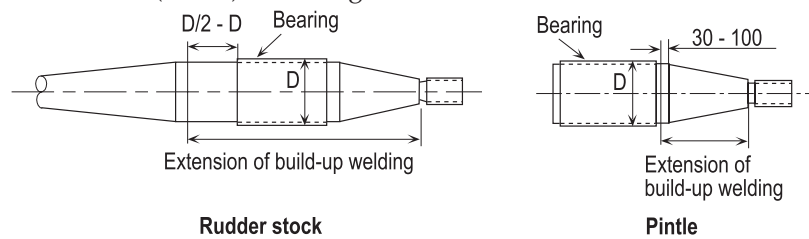
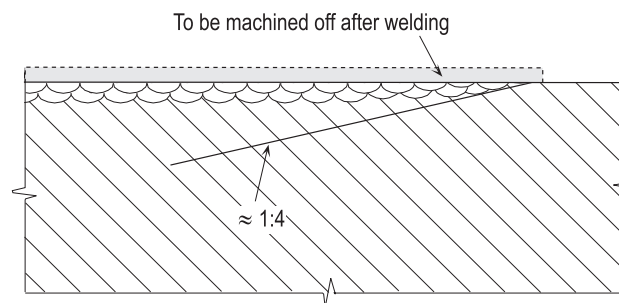
Figure 3 Rudder stock repair by welding

Replacing wasted material by similar ordinary weld material

- removal of the wasted area by machining and/or grinding, non-destructive examination for fractures (magnetic particle inspection preferred)
- build-up welding by automatic spiral welding (turning device) according to an approved welding procedure (weld process, preheating, welding consumables, etc.)
- extension of build-up welding over the area of large bending moments (shafts) according to the sketch

- sufficient number of weld layers to compensate removed material, at least one layer in excess (heat treatment of the remaining layer)
- transition at the end of the build-up welding according to the following sketch

- post weld heat treatment if required in special cases (never for stainless steel cladding on ordinary steel)
- final machining, at least two layers of welding material have to remain on the rudder stock (See the above sketch)
- non-destructive fracture examination

3.1.4 Rudder stocks and/or pintles may be repaired by welding replacing wasted material by similar weld material provided its chemical composition is suitable for welding, i.e. the carbon content must usually not exceed 0.25%. The welding procedures are to be identified as a function of the carbon equivalent (Ceq). After removal of the wasted area (corrosion, scratches, etc.) by machining and/or grinding the build-up welding has to be carried out by an automatic spiral welding according to an approved welding procedure. The welding has to be extended over the area of large bending moments (rudder stocks). In special cases post weld heat treatment has to be carried out according to the requirements of the Classification Society. After final machining, a sufficient number of layers of welding material have to remain on the rudder stock/pintle. A summary of the most important steps and conditions of this repair is shown in the **Figure 3**.

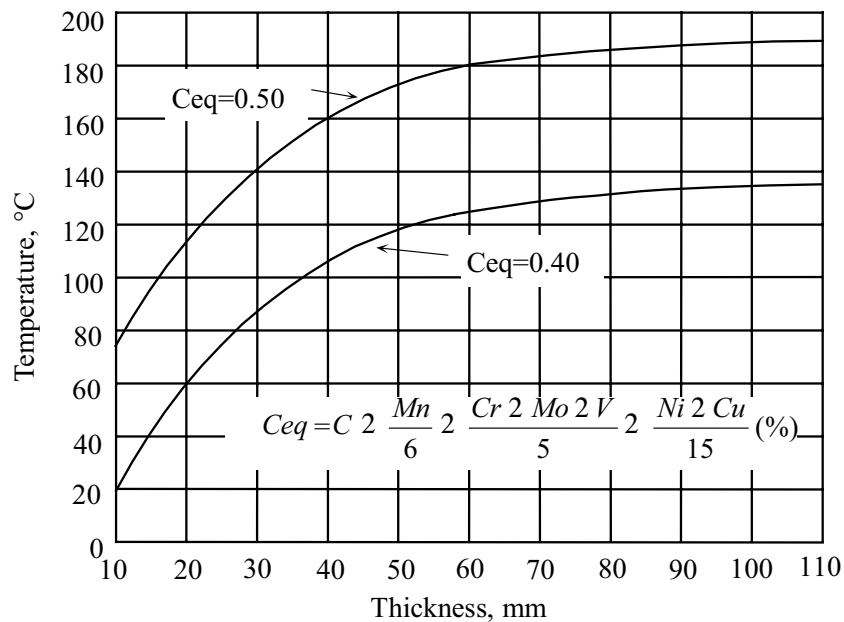
Diagram 1 Preheating temperature

3.2.5 As a guide, the preheating temperature can be obtained from **Diagram 1** using the plate thickness and carbon equivalent of the thicker structure.

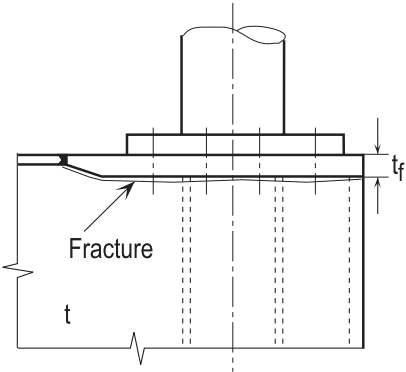
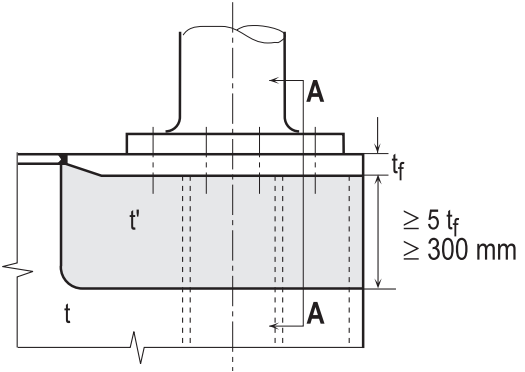
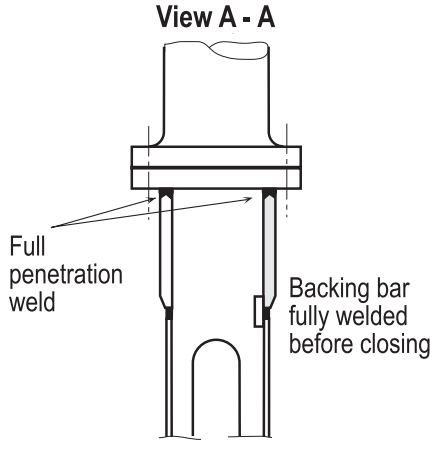
CONTAINER SHIPS		Guidelines for Surveys, Assessment and Repair of Hull Structures	
PART 2	Fore and aft end regions	EXAMPLE No.	
AREA 3	Stern frame, rudder arrangement and propeller shaft support	3	
Detail of damage		Fractures in connection of palm plate to rudder blade	
<p>Sketch of damage</p>

<p>Full penetration weld</p> <p>Backing bar fully welded before closing</p> <p>t = plate thickness [mm] t_f = actual flange thickness [mm] $t' = \frac{t_f}{3} + 5$ [mm], where $t_f < 50$ mm $t' = 3\sqrt{t_f}$ [mm], where $t_f \geq 50$ mm</p>	
<p>Notes on possible cause of damage</p> <p>1. Inadequate connection between horizontal coupling plate and rudder blade plating (insufficient plating thickness and/or insufficient fillet weld).</p>		<p>Notes on repairs</p> <p>1. Modification of detail design of the connection by increasing the plate thickness and full penetration welding.</p>

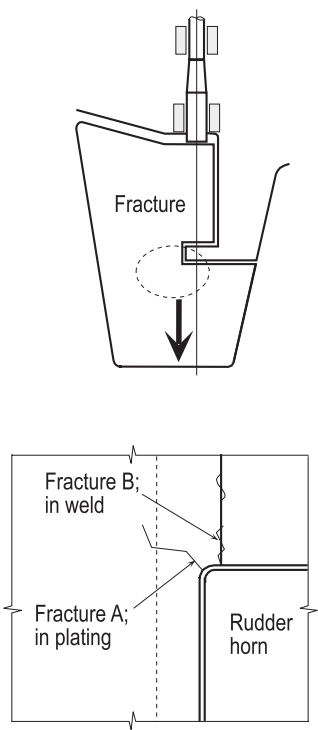
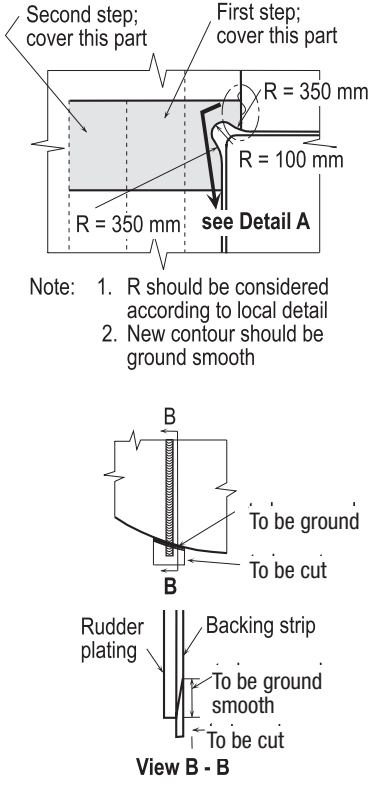
CONTAINER SHIPS		Guidelines for Surveys, Assessment and Repair of Hull Structures	
PART 2	Fore and aft end regions	EXAMPLE No.	
AREA 3	Stern frame, rudder arrangement and propeller shaft support	6	
Detail of damage		Fractures in rudder plating of semi-spade rudder in way of pintle cutout	
<p>Sketch of damage</p>

<p>The repair sketch shows two steps: 'First step; cover this part' with R = 100 mm and 'Second step; cover this part' with R = 350 mm. A note states: 'Note: 1. R should be considered according to local detail 2. New contour should be ground smooth'. A cross-section 'View B - B' shows 'Rudder plating', 'Backing strip', and areas 'To be ground' and 'To be cut'.</p>	
<p>Notes on possible cause of damage</p> <ol style="list-style-type: none"> 1. Inadequate design for stress concentration in way of pintle bearing (Fracture A). 2. Imperfection in welding seam (Fracture B). 		<p>Notes on repairs</p> <ol style="list-style-type: none"> 1. Fractured part to be cropped off. 2. Repair by two insert plates of modified, stress releasing contour. For the vertical seam no backing strip is used 100mm off contour, welding from both sides, to be ground after welding. 3. Variant (See Detail A): Repair as mentioned under 2 with the use of backing strip for the complete vertical seam. After welding backing strip partly removed by grinding.

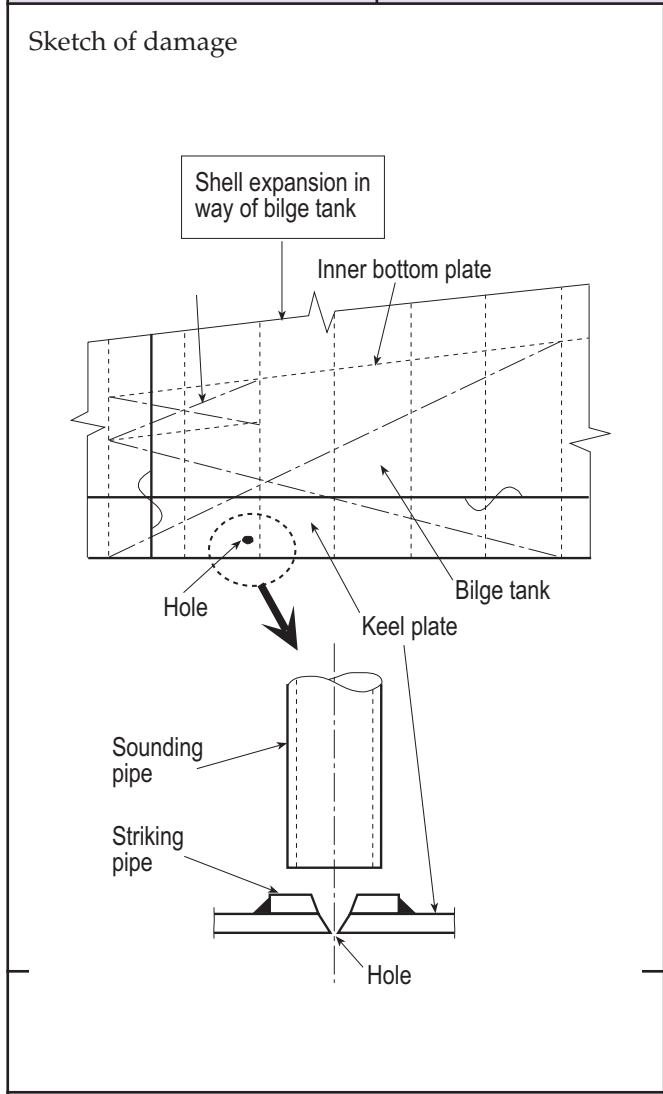
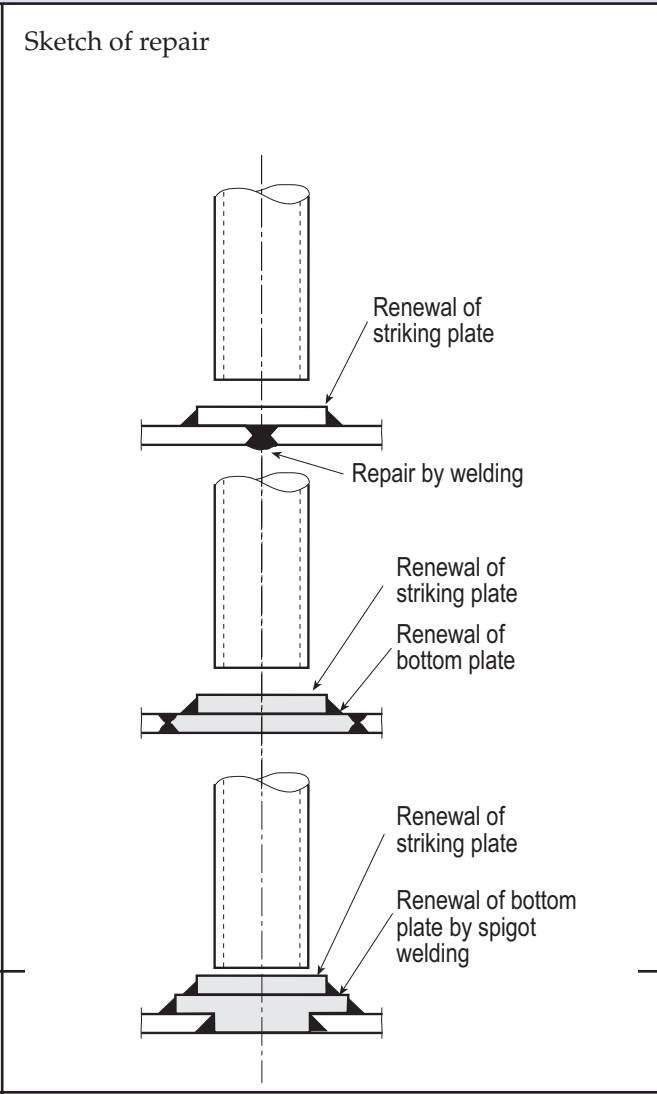
AREA 1	Engine room structure	2
--------	-----------------------	---

Detail of damage	Corrosion in the bottom plating under the sounding pipe in way of bilge storage tanks in the engine room
------------------	----------------------------------------------------------------------------------------------------------

1. Heavy corrosion of bottom plating under sounding pipe.

1. Corroded striking plate should be renewed.
2. Bottom plate should be repaired depending on the condition of corrosion.
 (Note) Repair by spigot welding can be applied to the structure only when the stress level is considered low. Generally this procedure cannot be applied to the repair of bottom plating of ballast tanks in cargo hold region.

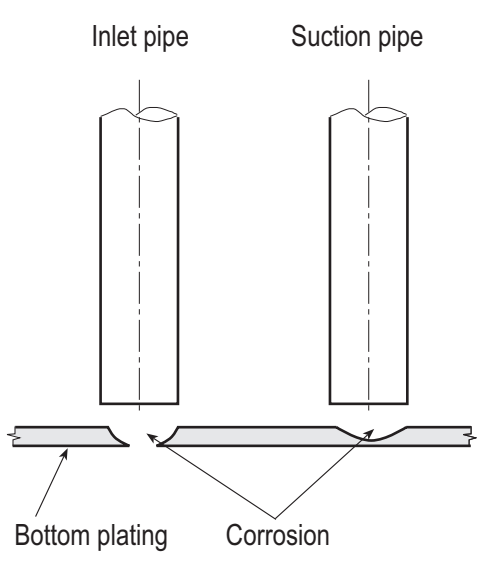
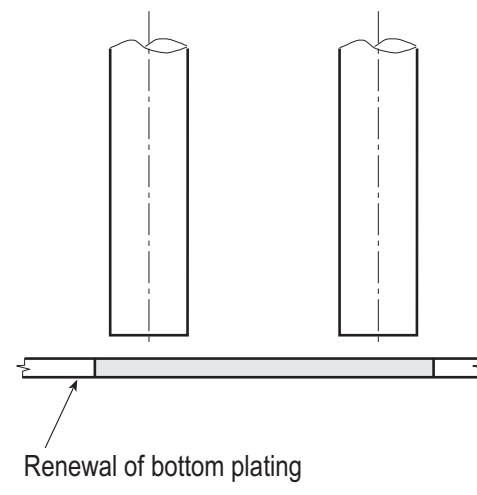
CONTAINER SHIPS		Guidelines for Surveys, Assessment and Repair of Hull Structures	
PART 3	Machinery and accommodaton spaces	EXAMPLE No.	
AREA 1	Engine room structure	3	
Detail of damage		Corrosion in the bottom plating under inlet/suction/pipe in way of the bilge storage tank in the engine room	
<p>Sketch of damage</p>

<p>Notes on possible cause of damage</p> <ol style="list-style-type: none"> 1. Heavy corrosion of bottom plating under the inlet/suction pipe. 		<p>Notes on repairs</p> <ol style="list-style-type: none"> 1. Corroded bottom plating is to be cropped and part renewed. Thicker plate is preferable. 2. Replacement of pipe end by enlarged conical opening (similar to the suction head in a ballast tank) is preferable.
